A Lifetime of Stress: Analysis and Treatment of an Inlaid Chinese Box

CNS 695 Master's Project

Katherine McFarlin

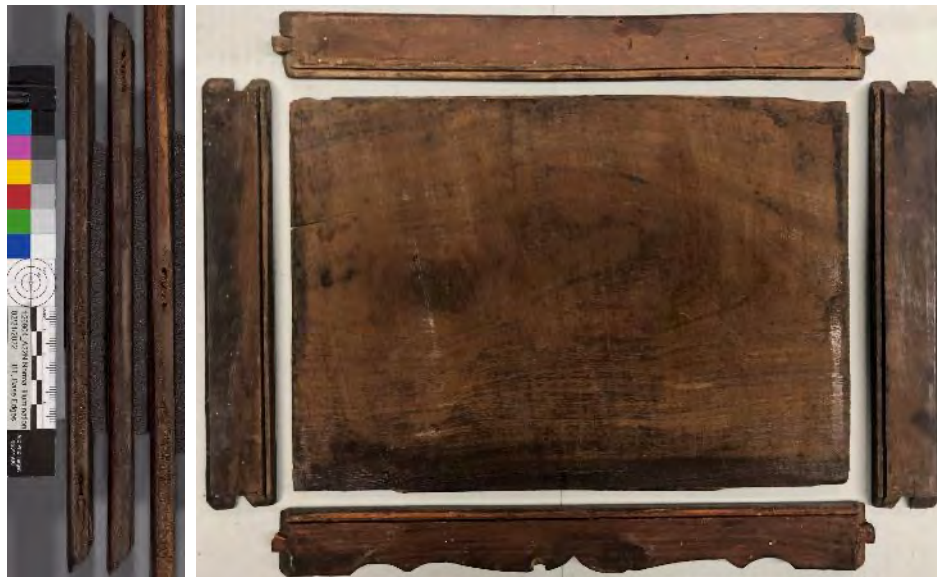
The base support was fully detached from the box and had arrived completely disassembled into its separate components, with the four rails of the skirt separated from each other and from the floor piece. The loose tenons that connected the base assembly to the main cabinet were broken, with fragments of the splines left behind in the mortises of both the cabinet and the individual rails (fig. 6). Small losses were visible in the rabbets of the floor piece, particularly near the corners, but overall the floor piece was complete and stable.

Fig. 6. Left: Upper edges of front and side rails, showing mortises with broken tenons in-situ, Right: Base components arranged in position, with interior grooves exposed

The mortise and tenon joints connecting the cabinet to the base were structurally critical, particularly for proper alignment of the components, so leaving the broken tenons in situ was not an option. The mortises needed to be cleared to allow for new loose tenons to be installed, as attempting to glue the cabinet to the base without the extra support of the tenons would almost certainly provide unsatisfactory or unstable results. Drilling new mortises in the adjacent wood was equally inappropriate, and beyond the skill level of the author. Thus, the decision was made to carefully drill out the tenon fragments with a hand-drill.

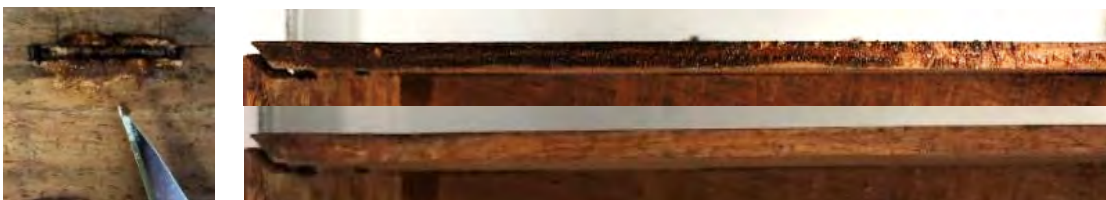
A large component of aqueous cleaning revolved around reduction of the excess proteinaceous glue found throughout the box. Total removal was not necessary, as animal glues have consistently been remoistened and reused in historic restorations for many generations (Rivers and Umney 2012). Leaving these traces in situ would also maintain some of the historical context and could act as a rudimentary barrier layer for fills or additional adhesive where needed. However, in some areas the old adhesive was at risk of impending uniform contact across the joint interfaces that needed to be re-glued. In these cases, cotton swabs moistened with room temperature deionized water were rolled over the excess glue to swell the adhesive, and then the residue was scraped down in layers using a metal spatula or scalpel (fig. 14). Once only a thin layer remained, the residue could be balled up with a rubber crepe eraser and removed mechanically. This procedure was crucial along the bottom edge of the cabinet walls, on the top rails of the base, and in the interior mortises of the cabinet, where the excess adhesive prevented insertion of the runners.

Fig. 14. Left: Adhesive reduction with a scalpel from an overfilled runner mortise.
Right: before and after adhesive reduction on the bottom edge of the cabinet

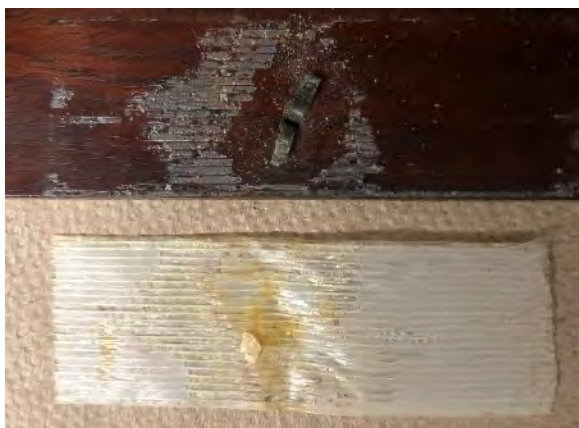
Fiber-reinforced packing tape was adhered to the interior of the front faces on four out of the five interior drawers, including the large bottom drawer. The drawer fronts may have been taped in order to keep the drawer tabs in place for shipping. The areas of adhesive that were exposed to air had crosslinked and become brittle, but the sections that were well-adhered remained tacky. The carrier was mechanically removed by pulling from one edge at a low angle, aided by a spatula to lift the degraded support fibers simultaneously and leave no brittle fragments behind (fig. 17). The bulk of the adhesive residue was removed with a crepe eraser, but solvents were needed to completely reduce the adhesive. Interestingly, the interior wood did not show signs of blanching or any other response to ethanol, suggesting that the drawers were not finished in the same manner as the main cabinet. Thus, the remaining adhesive was safely and efficiently reduced with an ethanol swab.

Fig. 17 - Tape removal from interior front wall of one of the small drawers. The brittle carrier has been removed, revealing the prongs and adhesive residue beneath.
