BUILDING-STRUCTURE INVENTORY FORM

- 1. BUILDING NAME(S): \_\_\_\_\_
- 2. COUNTY: Erie TOWN/CITY: Buffalo VILLAGE: \_\_\_\_\_
- 3. STREET LOCATION: 10 Crescent Ave
- 4. OWNERSHIP: a. public  b. private
- 5. PRESENT OWNER: Daniel Kreigler ADDRESS: 10 Crescent
- 6. USE: Original: Residential Present: Residential
- 7. ACCESSIBILITY TO PUBLIC: Exterior visible from public road: Yes  No   
Interior accessible: Explain by permission

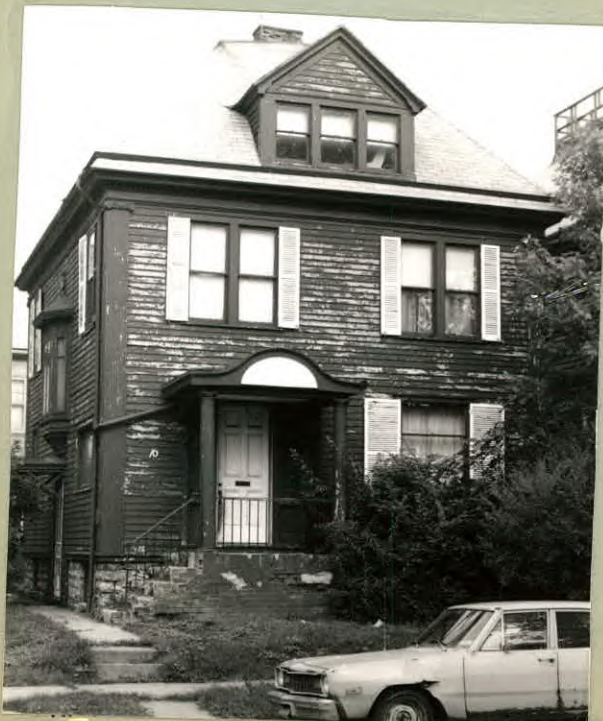
12. PHOTO: 9-32a

Two-story hip roofed structure has fluted ionic pilaster corner boards. Porch supported on doric columns has serpentine shaped roof with fan arch decoration. Colonial Revival doorway with sidelights. Oriel on south wall has large turned finial above its roof.
