**BUILDING-STRUCTURE INVENTORY FORM**

1. BUILDING NAME(S): \_\_\_\_\_
2. COUNTY: Erie TOWN/CITY: Buffalo VILLAGE: \_\_\_\_\_
3. STREET LOCATION: 18 Woodward Ave
4. OWNERSHIP: a. public  b. private
5. PRESENT OWNER: Marie Terranova ADDRESS: 18 Woodward
6. USE: Original: Residential Present: Residential
7. ACCESSIBILITY TO PUBLIC: Exterior visible from public road: Yes  No   
 Interior accessible: Explain by permission

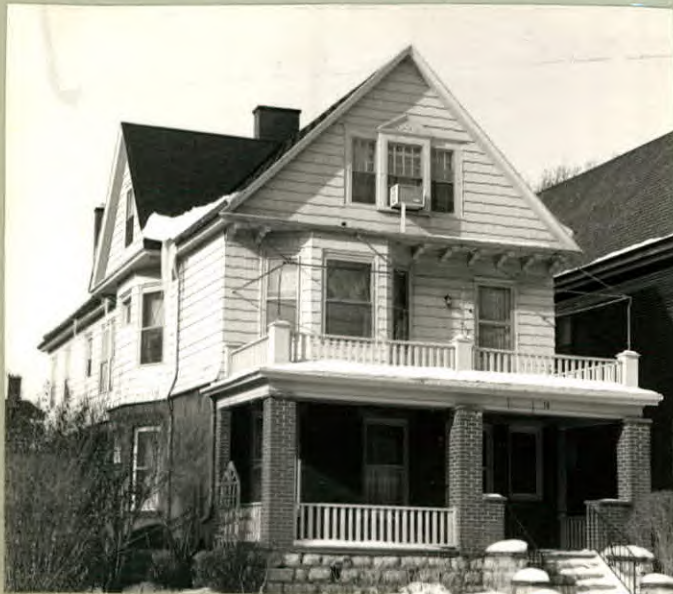
12. PHOTO: 20-11a

Two and a half story with Colonial Revival details. Front facing gable roof. Full-width porch with brick pier supports and stick balustrade. Upper porch stick balustrade. Brick first floor. First floor windows, square-headed 1/1 lights. Stone lintel. Second floor has semi-hexagonal bay window with square-headed 1/1 SIGNIFICANCE windows. Glass paneled porch door. Pedimented gable

19. DATE OF INITIAL CONSTRUCTION: 1904 has projecting eave supported by brackets. Pedimented center window 12/1 lights. Scroll motif in tympanum. 9/1 light windows flank.  
 ARCHITECT: \_\_\_\_\_  
 BUILDER: Entablature window surround. Pedimented gabled bay on side.
