**BUILDING-STRUCTURE INVENTORY FORM**

1. BUILDING NAME(S): \_\_\_\_\_
2. COUNTY: Erie TOWN/CITY: Buffalo VILLAGE: \_\_\_\_\_
3. STREET LOCATION: 23 Agassiz Cir
4. OWNERSHIP: a. public  b. private
5. PRESENT OWNER: Congregation Sisters ADDRESS: 23 Agassiz Circle, Bflo
6. USE: Original: Residence Present: Religious Offices
7. ACCESSIBILITY TO PUBLIC: Exterior visible from public road: Yes  No   
 Interior accessible: Explain By Permission

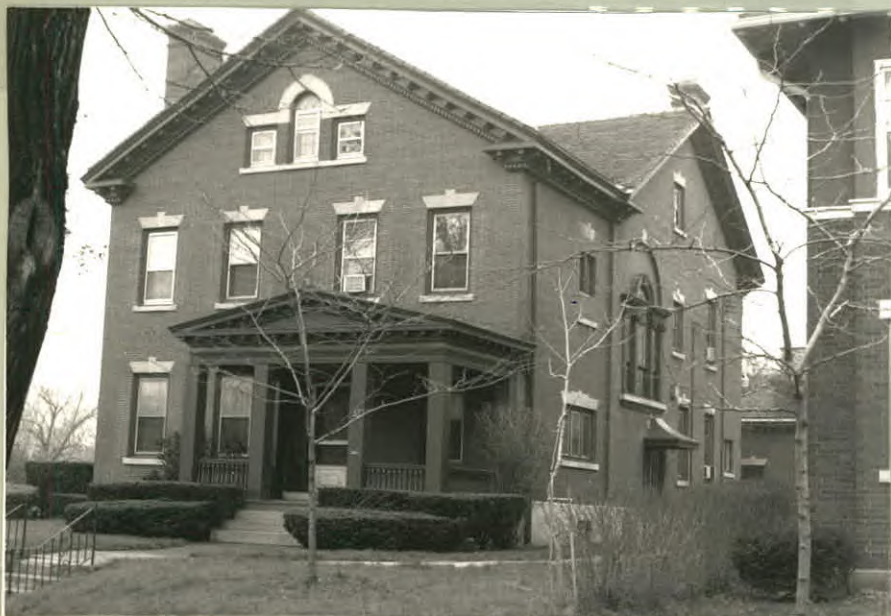
12. PHOTO: 41-10a

Two and one half story Italian Renaissance style. Cross gable roof. Cornice is embellished with modillion blocks and dentils. Cornice end returns. Pedimented gable porch has modillions under cornice. Square pier supports and spindle balustrade. First and second floor square-headed 6/1 windows. Stone window head with keystone. Palladian window in gable. East side has second story stairwell window. Highly executed Palladian window in blind arch. Stain glass.
