## BUILDING-STRUCTURE INVENTORY FORM

2. COUNTY: Erie TOWN/CITY:B	BuffaloVILLAGE:
3. STREET LOCATION: 17 Florence Ave	
4. OWNERSHIP: a. public □ b. private ☒	730 Parkside Ave.
5. PRESENT OWNER: Wilda Levin	ADDRESS: Buffalo, NY 14216

Residence

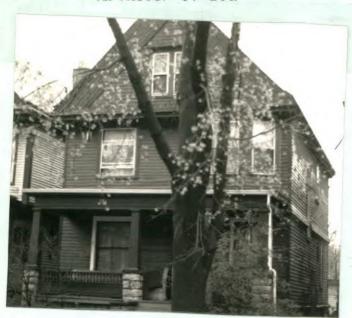
12. PHOTO: 37-25a

18.	OTHER NOTABLE FEA	TURES OF BUILDING AND SITE (including interior features if known):
T	wo and a half st	cory frame with front facing gable roof. Full-
W	idth flat roof p	porch. Rough cut, regular course stone base and
р	edestals. Tapel	red square Doric supports with column elaboration. a spindle balustrade. Glass paneled door flanked
		rinder. Biret floor left have bee double hung 1/1
SIC	NIFICANCE window	v. Plain window surround. Second floor semi-

19.	DATE OF INITIAL CON	STRUCTION: c. 1901
		hung 1/1 window. Pedimented
	ARCHITECT:	gable, shingled, has paired ple-hung 1/1 windows. Entablature window head.
	BUILDER: Saw-	-tooth shingles at window sill, top and raking
	corr	nice.
		CHITECTURAL IMPORTANCE: A typical frame gabled
r	esidence found to	throughout Buffalo. Florence Avenue extends from arkside Avenue, paralleling Robie Street.
L	ocated within th	ne first section of the Parkside subdivision to
b	e developed, Flo	prence Avenue was deeded to the city by Jacob
D	avis in 1887. A	Although Olmsted's early 1870's maps of "The
		street angling from the intersection of Main Parkside Avenue, when it was finally developed
		was modified to parallel Humboldt Avenue. It
		Il followed Olmsted's rule that a subdivision
S	treet "not lead	with special directness toward the town."
