BUILDING-STRUCTURE INVENTORY FORM

DIVISION FOR HISTORIC PRESERVATION
NEW YORK STATE PARKS AND RECREATION
ALBANY, NEW YORK (518) 474-0479

- 1. BUILDING NAME(S): _____
- 2. COUNTY: Erie TOWN/CITY: Buffalo VILLAGE: _____
- 3. STREET LOCATION: 14 Robie St.
- 4. OWNERSHIP: a. public b. private
- 5. PRESENT OWNER: Marie Thornton ADDRESS: 14 Robie
- 6. USE: Original: Residential Present: Residential
- 7. ACCESSIBILITY TO PUBLIC: Exterior visible from public road: Yes No
Interior accessible: Explain by permission

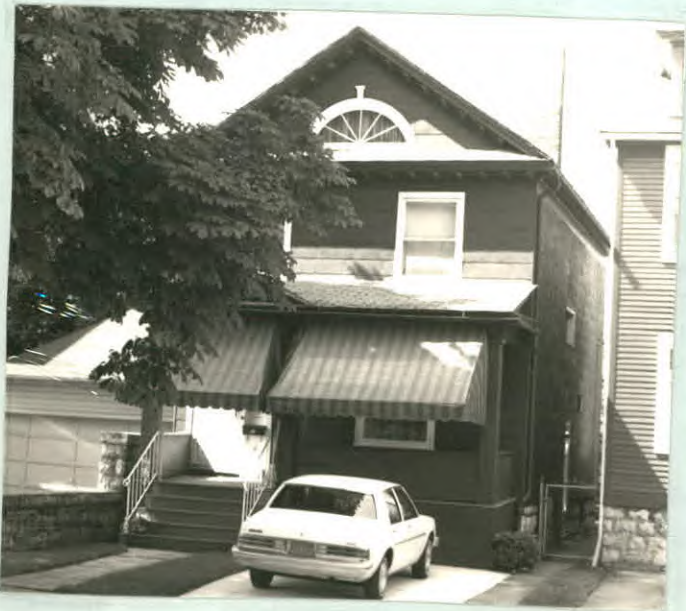
12. PHOTO: 30-8a

Two and a half story frame with Colonial Revival style influence. Front facing gable roof. Full-width shed roof porch. Square Doric supports. Console brackets under eave. Glass and wood paneled door. First floor right bay has single-hung 1/1 window. Second floor has two double-hung 1/1 windows. Pedimented gable has modillions under cornice and raking cornice.

19. DATE OF INITIAL CONSTRUCTION: c. 1900 Semi-circular window in
 ARCHITECT: _____ gable. Moulded surround
 with keystones.
 BUILDER: _____
