BUILDING-STRUCTURE INVENTORY FORM

- BUILDING NAME(S): _____
- COUNTY: Erie TOWN/CITY: Buffalo VILLAGE: _____
- STREET LOCATION: 16 Tillinghast Pl
- OWNERSHIP: a. public b. private
- PRESENT OWNER: Edward W. Becker ADDRESS: 16 Tillinghast Place, Bflo
- USE: Original: Residence Present: Residence
- ACCESSIBILITY TO PUBLIC: Exterior visible from public road: Yes No
Interior accessible: Explain By Permission

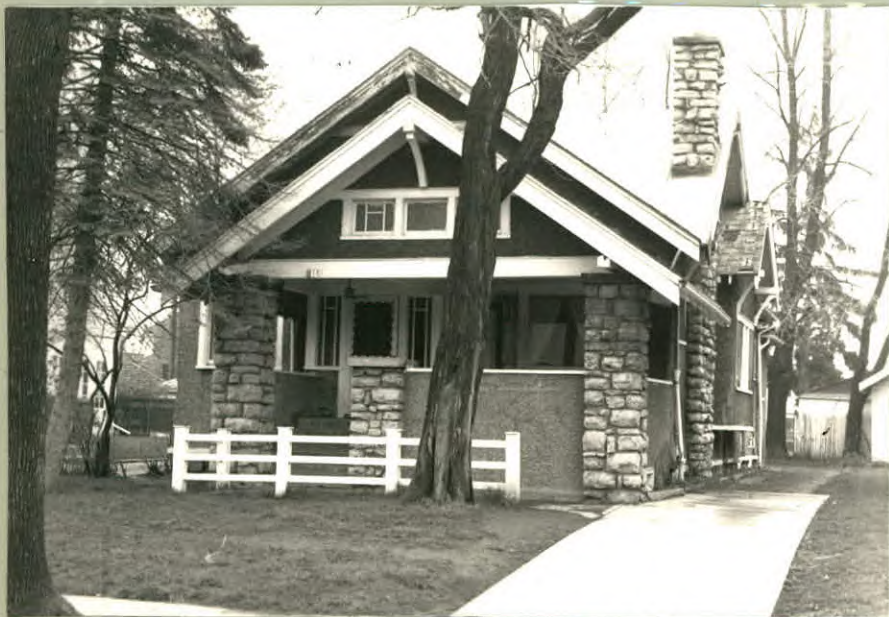
12. PHOTO: 40-23a

Two story Craftsman Style. Front facing gable roof with separate gabled porch roof. Bracket in the eave under peak of gable. The porch has stone piers with stucco railing. Porch gable has tri-part window, single light center window with vertical lights in side windows. This window style is imitated on the first floor windows, but on a larger scale. Gabled bay window on east side has end bracket roof supports.
