BUILDING-STRUCTURE INVENTORY FORM

- BUILDING NAME(S): _____
- COUNTY: Erie TOWN/CITY: Buffalo VILLAGE: _____
- STREET LOCATION: 19 Robie St.
- OWNERSHIP: a. public b. private
- PRESENT OWNER: Lenke Moni ADDRESS: 19 Robie
- USE: Original: Residential Present: Residential
- ACCESSIBILITY TO PUBLIC: Exterior visible from public road: Yes No
Interior accessible: Explain by permission

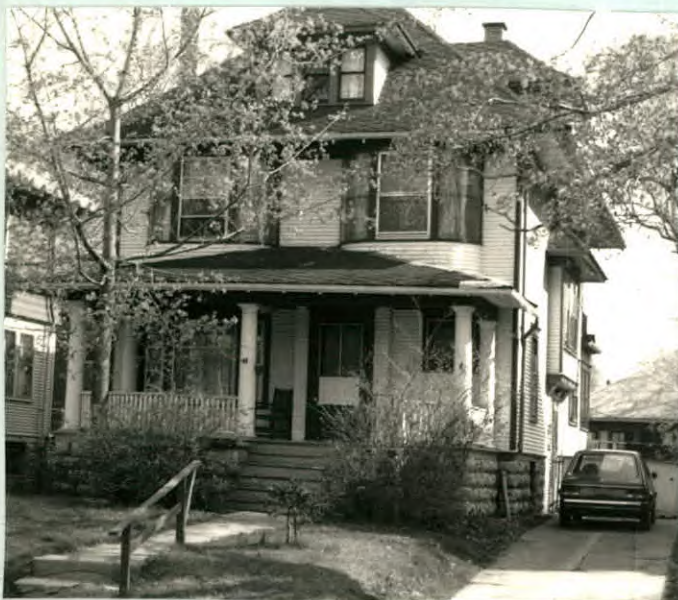
12. PHOTO: 41-33a

Two and a half story American Four Square. Hip roof with exposed rafter tails under extending eave. Full-width hip roof porch. Exposed rafter tails under extending eave. Rough cut, regular course stone base. Doric column supports. Stick balustrade with left side bowed. Projecting boxed entrance bay. Glass and wood paneled door. Entrance flanked on

SIGNIFICANCE one side by leaded square window. First floor tri-part window; single hung with
 19. DATE OF INITIAL CONSTRUCTION: c. 1900 leded top lights. Entablature
 ARCHITECT: window and door surround. Second floor end bays have
bowed bays. Double-hung 1/1 center windows with leaded
 BUILDER: glass side windows. Hip roof dormer with extending
eaves. Three double-hung 1/1 windows.
