BUILDING-STRUCTURE INVENTORY FORM

DIVISION FOR HISTORIC PRESERVATION
 NEW YORK STATE PARKS AND RECREATION
 ALBANY, NEW YORK (518) 474-0479

1. BUILDING NAME(S): _____
2. COUNTY: Erie TOWN/CITY: Buffalo VILLAGE: _____
3. STREET LOCATION: 26 Woodward Ave
4. OWNERSHIP: a. public b. private
5. PRESENT OWNER: Joseph Cardina ADDRESS: 26 Woodward
6. USE: Original: Residential Present: Residential
7. ACCESSIBILITY TO PUBLIC: Exterior visible from public road: Yes No
 Interior accessible: Explain by permission

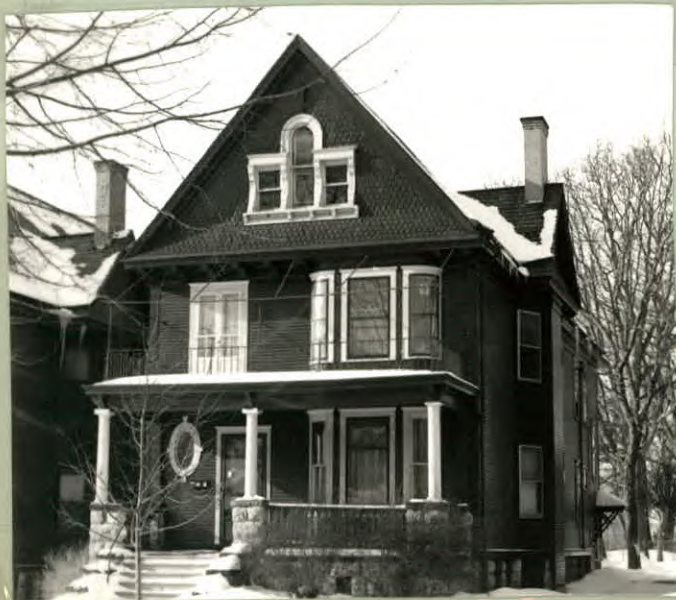
12. PHOTO: 20-14a

8. BUILDING MATERIAL: a. clapboard b. stone c. brick d. board and batten
 e. cobblestone f. shingles g. stucco other: _____
9. STRUCTURAL SYSTEM: a. wood frame with interlocking joints
 (if known) b. wood frame with light members
 c. masonry load bearing walls
 d. metal (explain) _____
 e. other _____
10. CONDITION: a. excellent b. good c. fair d. deteriorated
11. INTEGRITY: a. original site b. moved if so, when? _____
 c. list major alterations and dates (if known):
Remodeled into 4 family in 1939
Upper porch balustrade altered.

Two and a half story Colonial Revival style. Front-facing steep-pitched gable roof. Full-width porch has rough cut, regular coursed stone base. Spindle balustrade. Doric columns support entablature with ancones above each column. Glass paneled front door with flanking elliptical window. First and second floor segmental arched bay windows. Window and door surrounds with capping cornice. Projecting pedimented gable, shingled. Brackets under projection.

19. DATE OF INITIAL CONSTRUCTION: 1906
ARCHITECT: _____
BUILDER: Palladian-styled window. Fluted building end pilaster strips. Semi-hexagonal gabled bay on north side.
