**BUILDING-STRUCTURE INVENTORY FORM**

1. BUILDING NAME(S): \_\_\_\_\_
2. COUNTY: Erie TOWN/CITY: Buffalo VILLAGE: \_\_\_\_\_
3. STREET LOCATION: 2166 Main St
4. OWNERSHIP: a. public  b. private
5. PRESENT OWNER: Joseph Gambacorta ADDRESS: 2166 Main Street
6. USE: Original: Residential Present: Residential
7. ACCESSIBILITY TO PUBLIC: Exterior visible from public road: Yes  No   
 Interior accessible: Explain by permission

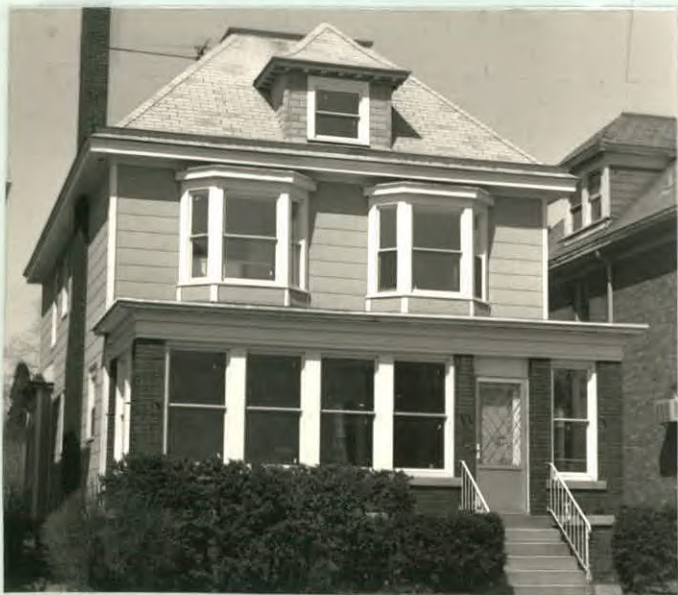
12. PHOTO: 28-22a

Two and a half story frame residence with hip roof. Extending eaves. Full-width flat roof enclosed porch. Extending porch eaves. Brick base and piers. Glass and wood door. Diamond tracery decorates glass. Double-hung 1/1 window flanks door on one side. Four 1/1 windows to left of entrance. Brick piers flank window bays.

**SIGNIFICANCE** Second floor has two semi-hexagonal bays. Capping cornice. Double-hung

19. DATE OF INITIAL CONSTRUCTION: 1909 windows, 1/1 lights. Hip roof dormer with flared eave. Modillions under eave. 1/1 sash-type window.  
 ARCHITECT: \_\_\_\_\_  
 BUILDER: South side has brick exposed chimney.
