**BUILDING-STRUCTURE INVENTORY FORM**

1. BUILDING NAME(S): \_\_\_\_\_
2. COUNTY: Erie TOWN/CITY: Buffalo VILLAGE: \_\_\_\_\_
3. STREET LOCATION: 30 Crescent Ave
4. OWNERSHIP: a. public  b. private
5. PRESENT OWNER: James Keech ADDRESS: 30 Crescent
6. USE: Original: Residential Present: Residential
7. ACCESSIBILITY TO PUBLIC: Exterior visible from public road: Yes  No   
 Interior accessible: Explain by permission

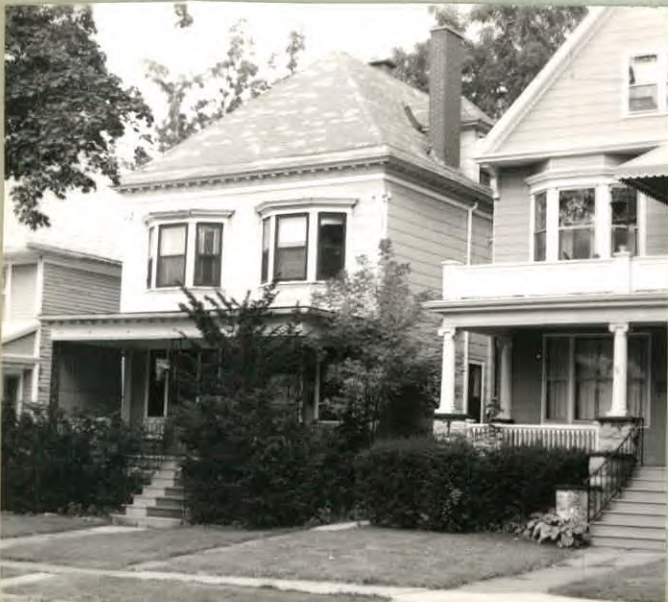
12. PHOTO: 9-28a

18. OTHER NOTABLE FEATURES OF BUILDING AND SITE (including interior features if known):  
Vernacular classical revival. Two-story hip roofed structure has no dormer on facade. Classical cornice with modillions is repeated in full-width porch. Corner boards are narrow fluted ionic pilasters. Pair of second story bay windows have fluted pilasters and dentillated cornices.
