BUILDING-STRUCTURE INVENTORY FORM

- BUILDING NAME(S): _____
- COUNTY: Erie TOWN/CITY: Buffalo VILLAGE: _____
- STREET LOCATION: 58 Robie St.
- OWNERSHIP: a. public b. private
- PRESENT OWNER: Peter Bordin ADDRESS: 58 Robie
- USE: Original: Residential Present: Residential
- ACCESSIBILITY TO PUBLIC: Exterior visible from public road: Yes No
Interior accessible: Explain by permission

19. DATE OF INITIAL CONSTRUCTION: c. 1905

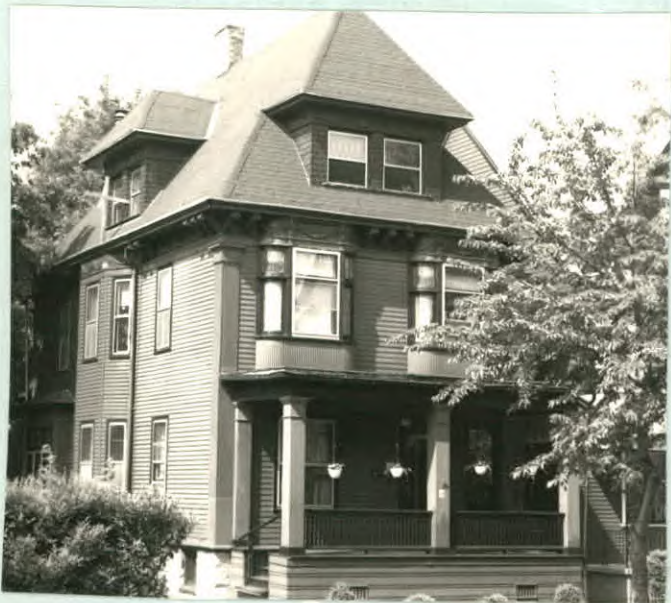
12. PHOTO: 30-2a

Two and a half story Colonial Revival style. Steep-pitched hip roof with paired curved brackets under eave. Full-width flat roof porch with eave overhang. Shingled base. Square Doric supports and stick balustrade. Glass paneled door flanked by double-hung 1/1 windows. Second floor has two bowed bays. Single hung windows with leaded glass top lights. Fluted apron. Band of

ARCHITECT: fluted Doric pilasters. Hip roof dormer, whose roof is an extension of the roof proper. Two double hung 1/1 windows with diamond-shaped leading in top light.
BUILDER: Band of trim below eave decorated with garlands.

20. HISTORICAL AND ARCHITECTURAL IMPORTANCE: A good example of Colonial Revival style with Classical details. Porch is a later addition. Robie Street extends from Parkside Avenue to Main Street. Located in the center of the first section of the Parkside subdivision to be developed, on lands owned by Jacob Davis, Robie Street was deeded to the city in December 1887. Olmsted's early 1870's maps of "The Parkside" show a street angling from Humboldt to Parkside Avenue; however when Robie Street was laid out, it paralleled Humboldt Avenue. The street nevertheless still followed Olmsted's plan to have short cross streets in the subdivision, giving residents easy access to main thoroughfares and the park.
