**BUILDING-STRUCTURE INVENTORY FORM**

1. BUILDING NAME(S): \_\_\_\_\_
2. COUNTY: Erie TOWN/CITY: Buffalo VILLAGE: \_\_\_\_\_
3. STREET LOCATION: 37 Crescent Ave
4. OWNERSHIP: a. public  b. private
5. PRESENT OWNER: Halbert Stafford ADDRESS: 37 Crescent
6. USE: Original: Residential Present: Residential
7. ACCESSIBILITY TO PUBLIC: Exterior visible from public road: Yes  No   
 Interior accessible: Explain by permission

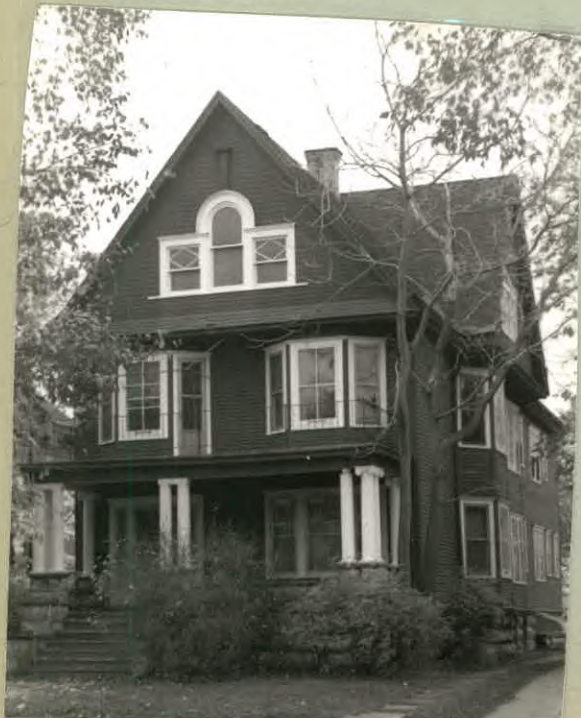
12. PHOTO: 11-0a

18. OTHER NOTABLE FEATURES OF BUILDING AND SITE (including interior features if known):  
Two and a half story with front facing gable. Full-width porch has paired columns. Ionic columns on west side. Rough cut, regular course stone base. Glass paneled door with sidelights. Tri-part first floor window. Second floor has a pair of semi-hexagonal bays. 1/1 windows. Pedimented gable, shingled.  
Palladian window.
