**BUILDING-STRUCTURE INVENTORY FORM**

- BUILDING NAME(S): \_\_\_\_\_
- COUNTY: Erie TOWN/CITY: Buffalo VILLAGE: \_\_\_\_\_
- STREET LOCATION: 105 Florence Ave
- OWNERSHIP: a. public  b. private  3 Walker Rd., RR #1 Box 96
- PRESENT OWNER: Clifford Weiss ADDRESS: Atkinson, NH 03811
- USE: Original: Residential Present: Residential
- ACCESSIBILITY TO PUBLIC: Exterior visible from public road: Yes  No   
Interior accessible: Explain by permission

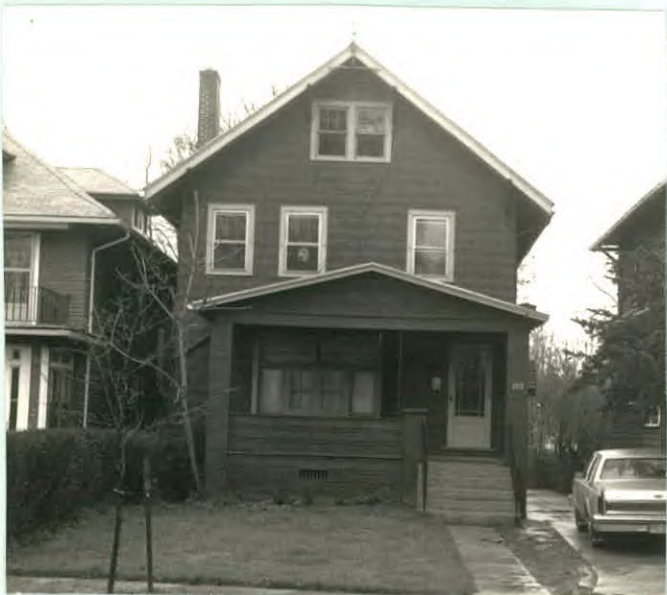
12. PHOTO: 37-32a

Two and a half story with Craftsman style influence. Front facing gable roof with bargeboard and triangular knee brackets. Partial-width gabled porch. End pier supports. Shingled rail. Glass paneled door with horizontal and vertical border. Tri-part first floor window. Center paired 4-light windows flanked by single-light windows. Fourteen light transom. Second floor

19. DATE OF INITIAL CONSTRUCTION: 1913 left bay has two double-hung  
6/1 windows. Right bay 6/1  
ARCHITECT: \_\_\_\_\_ window. Gable has paired  
6/1 windows. Plain window  
BUILDER: \_\_\_\_\_ surround.
