BUILDING-STRUCTURE INVENTORY FORM

- BUILDING NAME(S): _____
- COUNTY: Erie TOWN/CITY: Buffalo VILLAGE: _____
- STREET LOCATION: 68 Robie St.
- OWNERSHIP: a. public b. private
- PRESENT OWNER: Richard Prosser ADDRESS: 68 Robie
- USE: Original: Residential Present: Residential
- ACCESSIBILITY TO PUBLIC: Exterior visible from public road: Yes No
Interior accessible: Explain by permission

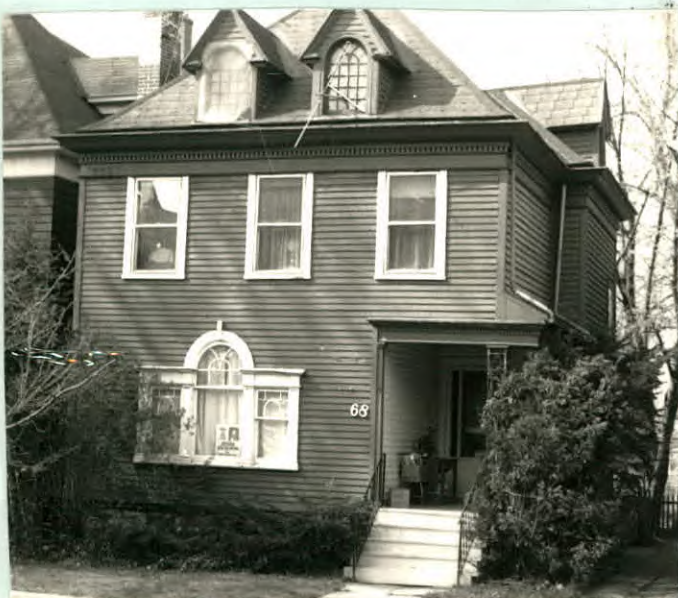
12. PHOTO: 41-35a

Two and a half story Colonial Revival style. Hip roof with extending eave. Recessed corner entrance. Entablature with dentils under cornice. Glass and wood paneled door with 3/4 sidelights. Palladian window on first floor. Second floor has three double-hung 1/1 light windows situated under band of trim below roof eave. Plain window surround. Dentils under roof cornice.

19. DATE OF INITIAL CONSTRUCTION: 1894 Corner boards. Two pedimented
 ARCHITECT: _____ gable dormers with cornice
 end returns. Round arched
 BUILDER: _____ lighted window.
