**BUILDING-STRUCTURE INVENTORY FORM**

1. BUILDING NAME(S): \_\_\_\_\_
2. COUNTY: Erie TOWN/CITY: Buffalo VILLAGE: \_\_\_\_\_
3. STREET LOCATION: 70 Woodward Ave
4. OWNERSHIP: a. public  b. private
5. PRESENT OWNER: Madelyn Drown ADDRESS: 70 Woodward
6. USE: Original: Residential Present: Residential
7. ACCESSIBILITY TO PUBLIC: Exterior visible from public road: Yes  No   
 Interior accessible: Explain by permission

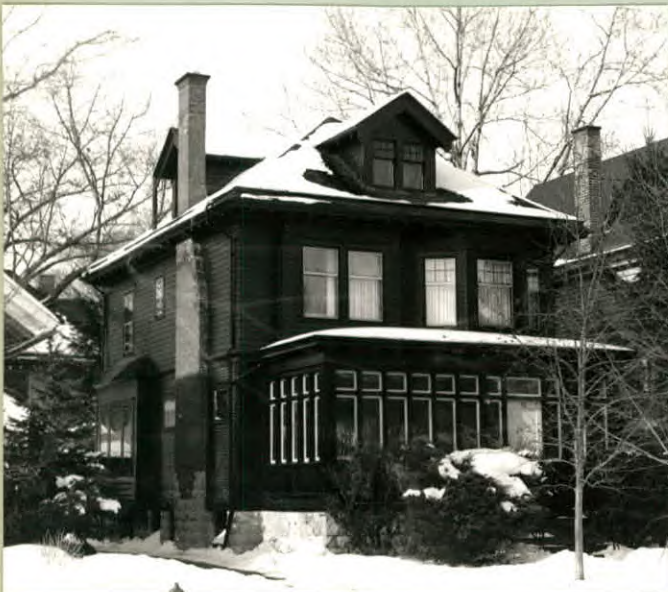
12. PHOTO: 20-21a

Two and a half story American Four Square. Hip roof with brackets under roof eave. Full-width entrance porch, enclosed, has horizontal band of single light windows with transom. Wood paneled door with transom. Brackets under cornice. Paneled apron. Boxed bay window on second floor, single light with leaded top light.

**SIGNIFICANCE** Semi-hexagonal bay window, center 8/1 with 6/1 sidelights.

19. DATE OF INITIAL CONSTRUCTION: 1907 Gabled dormer has bargeboard,  
rafter tails under eave.  
ARCHITECT: \_\_\_\_\_ 6/1 light windows. Stick  
styling in gable.  
BUILDER: \_\_\_\_\_
