BUILDING-STRUCTURE INVENTORY FORM

- BUILDING NAME(S): _____
- COUNTY: Erie TOWN/CITY: Buffalo VILLAGE: _____
- STREET LOCATION: 99 Robie St.
- OWNERSHIP: a. public b. private
- PRESENT OWNER: Frank Scheuttle ADDRESS: 99 Robie
- USE: Original: Residential Present: Residential
- ACCESSIBILITY TO PUBLIC: Exterior visible from public road: Yes No
Interior accessible: Explain by permission

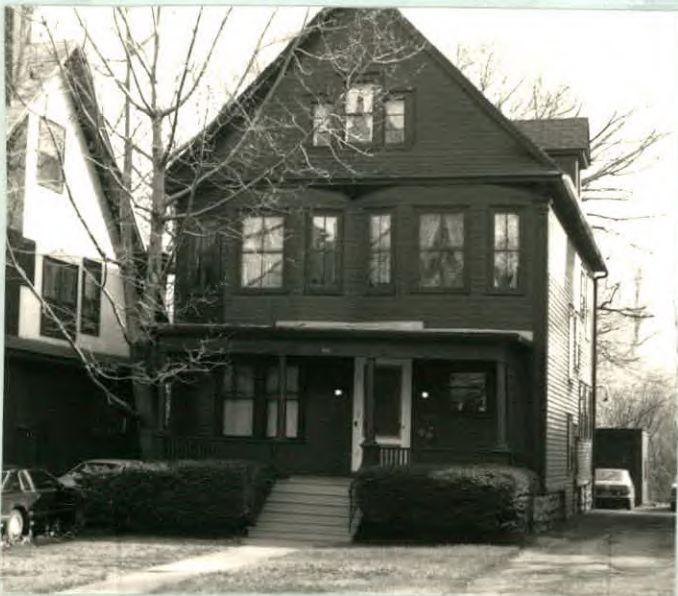
12. PHOTO: 41-28a

Two and a half story Colonial Revival style. Front facing gable roof. Full-width flat roof porch. Rough-cut regular course stone base. Doric columns support entablature with projecting cornice. Stick balustrade. Glass and wood paneled door flanked on one side by small double-hung l/l window. First floor paired double-hung l/l windows. Entablature window and door surrounds.

19. DATE OF INITIAL CONSTRUCTION: c. 1900
 ARCHITECT: hexagonal bays. Double hung l/l windows. Entablature window surrounds. Band of trim below roof eave.
 BUILDER: Brackets placed at ends and center of eave. Paneled Doric end pilaster strips. Pedimented gable has

20. HISTORICAL AND ARCHITECTURAL IMPORTANCE: tri-part window; center l/l light with flanking smaller l/l windows.
 A typical gabled form of the Colonial Revival style. Robie Street extends from Parkside Avenue to Main Street. Located in the center of the first section of the Parkside subdivision to be developed, on lands owned by Jacob Davis, Robie Street was deeded to the city in December 1887. Olmsted's early 1870's maps of "The Parkside" show a street angling from Humboldt to Parkside Avenue; however when Robie Street was laid out, it paralleled Humboldt Avenue. The street nevertheless still followed Olmsted's plan to have short cross streets in the subdivision, giving residents easy access to main thoroughfares and the park.
