**BUILDING-STRUCTURE INVENTORY FORM**

1. BUILDING NAME(S): \_\_\_\_\_
2. COUNTY: Erie TOWN/CITY: Buffalo VILLAGE: \_\_\_\_\_
3. STREET LOCATION: 2234 Main St
4. OWNERSHIP: a. public  b. private
5. PRESENT OWNER: Daniel McCue ADDRESS: 2234 Main Street
6. USE: Original: Residential Present: Residential
7. ACCESSIBILITY TO PUBLIC: Exterior visible from public road: Yes  No   
 Interior accessible: Explain by permission

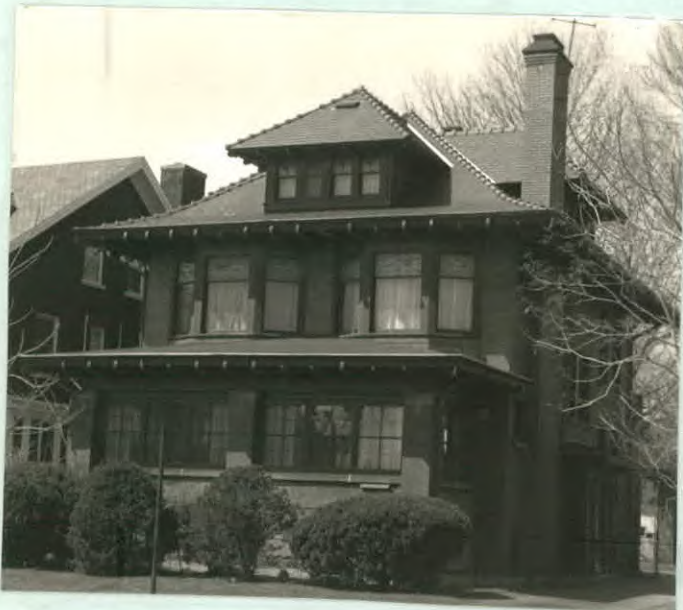
12. PHOTO: 29-3a

Two and a half story American Four Square. Hip roof with flared extending eaves. Exposed rafter tails with accented round ends. Red tile roof cresting. Full-width hip roof wing has exposed rafter tails under eave. Doric pilaster strips with capital elaboration flank window bays. Three double sash windows, 8 lights each. Second floor has two semi-hexagonal bays, single light windows

19. DATE OF INITIAL CONSTRUCTION: c. 1914  
 ARCHITECT: \_\_\_\_\_ with leaded transom. Hip roof dormer. Exposed  
 BUILDER: \_\_\_\_\_ rafter tails under extending eaves. Red tile roof cresting. Four double hung windows, 4/1 lights.
