**BUILDING-STRUCTURE INVENTORY FORM**

DIVISION FOR HISTORIC PRESERVATION  
NEW YORK STATE PARKS AND RECREATION  
ALBANY, NEW YORK (518) 474-0479

- 1. BUILDING NAME(S): \_\_\_\_\_
- 2. COUNTY: Erie TOWN/CITY: Buffalo VILLAGE: \_\_\_\_\_
- 3. STREET LOCATION: 56 Summit Ave
- 4. OWNERSHIP: a. public  b. private
- 5. PRESENT OWNER: F & M Associates ADDRESS: 90 Jewett Pkwy, Buffalo, NY 14214
- 6. USE: Original: Residential Present: Residential
- 7. ACCESSIBILITY TO PUBLIC: Exterior visible from public road: Yes  No   
Interior accessible: Explain by permission

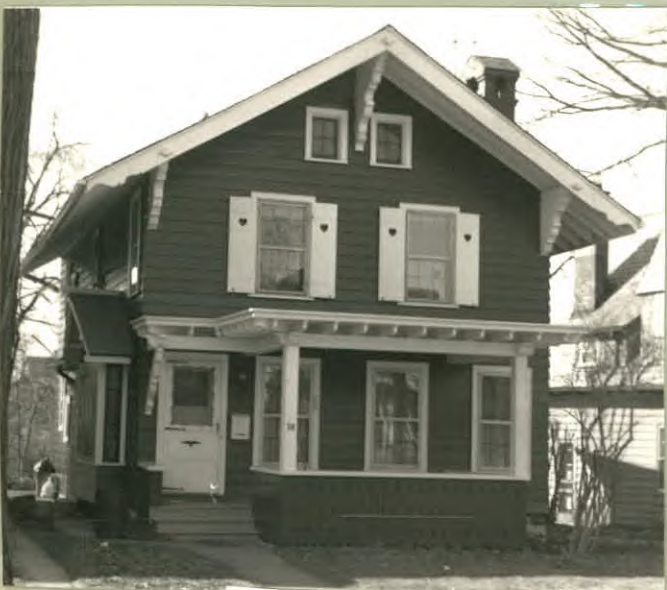
12. PHOTO: 27-12a

Two and a half story Craftsman style. Front facing gable roof with extending side eaves. Exposed rafter tails. Bargeboard with curved ends. Over-scale curvilinear brackets. Partial width trellised porch. Trellised entrance hood with supporting bracket. Glass and wood paneled door. First and second floor SIGNIFICANCE 6/6 windows. Second floor window shutters with heart-shaped cut-out pattern.

19. DATE OF INITIAL CONSTRUCTION: c. 1902 Gable has pair of 4 light windows.  
 ARCHITECT: \_\_\_\_\_  
 BUILDER: \_\_\_\_\_
