BUILDING-STRUCTURE INVENTORY FORM

1. BUILDING NAME(S): _____
2. COUNTY: Erie TOWN/CITY: Buffalo VILLAGE: _____
3. STREET LOCATION: 133 Parkside Ave
4. OWNERSHIP: a. public b. private
5. PRESENT OWNER: Delmar A. Lee ADDRESS: 133 Parkside Avenue
6. USE: Original: Residential Present: Residential
7. ACCESSIBILITY TO PUBLIC: Exterior visible from public road: Yes No
 Interior accessible: Explain by permission

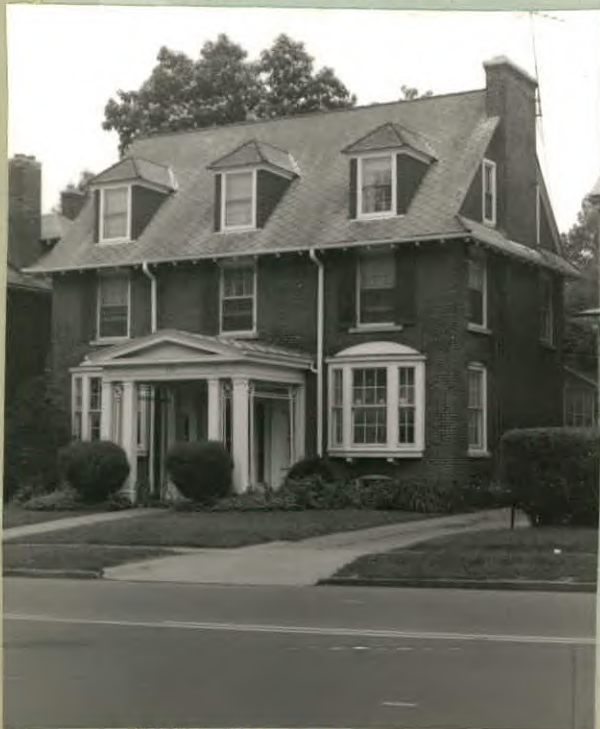
12. PHOTO: 13-4

Two Story Colonial Revival Style. Gable roof with three hipped dormers. Dormers have six light over six light windows. Exposed rafters in eaves. Exterior brick chimney on south side of house. Windows are all six light over six light. Wooden shutters on second story front facade windows. Two bay windows on either side of front entranceway. Relieving arch with stucco infill above bay windows. Front porch has a pedimented gable

18. roof with a plain cornice. The porch has four squared columns with lattice work between the columns. Entranceway has sidelights and pilasters. House is brick veneer.
