BUILDING-STRUCTURE INVENTORY FORM

1. BUILDING NAME(S): _____
2. COUNTY: Erie TOWN/CITY Buffalo VILLAGE: _____
3. STREET LOCATION: 141 Parkside Ave.
4. OWNERSHIP: a. public b. private
5. PRESENT OWNER Lawrence E. Burke ADDRESS: 141 Parkside Avenue
6. USE: Original: Residential Present: Residential
7. ACCESSIBILITY TO PUBLIC: Exterior visible from public road: Yes No
 Interior accessible: Explain by permission

19. DATE OF INITIAL CONSTRUCTION: c. 1915

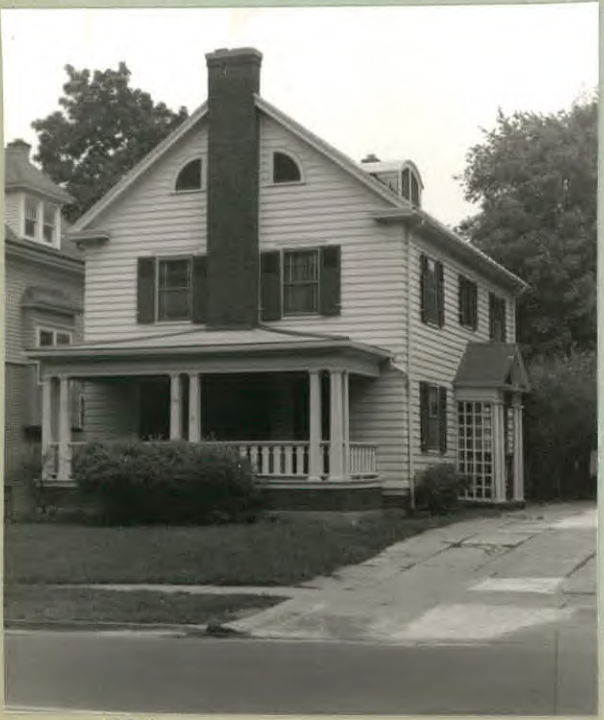
12. PHOTO: 13-6

Two story Colonial Revival style house. Gable roof with returns and a plain cornice. Eyebrow dormer on north and sides of roof. Entranceway on south side of house has a pedimented gable roof, paired doric columns and wooden lattice work on the sides. Exterior brick chimney in the center of the front facade. Quarter circle windows on either side of chimney in gable. Six light over single pane windows on all sides of the SIGNIFICANCE house. Open porch across front of house has a hip roof, a plain

18. cornice paired boxed columns and a wooden cut out design balustrade. Multi-paned french doors on either side of the chimney lead out to porch. Porch has a brick foundation. House has a stone foundation. Windows have wooden shutters.
