E	UILDING-STRUCTURE INVENTORY FORM	
	UILDING-STRUCTURE INVENTORY FORM	
	IVISION FOR HISTORIC PRESERVATION OUAD	
	Tew YORK STATE PARKS AND RECREATION SERIES	1
A	LBANY, NEW YORK (518) 474-0479 NEG. NO.	
		L
	YOUR NAME: BUFFALO FRIENDS OF OLMSTED PARKS DATE: July 3, 1984

P. O. BOX 590	
	YOUR ADDRESS: BUFFALO, NEW YORK 14205 = 0590 TELEPHONE:	
	ORGANIZATION (if any):	
*	* * * * * * * * * * * * * * * * * * * *	
	DENTIFICATION	
1	. BUILDING NAME (S):	
2	. COUNTY: Erie TOWN/CITY:Buffalo VILLAGE:	
3	STREET LOCATION: 74 Russell Ave	
	. OWNERSHIP: a. public 🗆 b. private 🖾	
	PRESENT OWNER: Michael Ernst ADDRESS: 74 Russell	
6	USE: Original: Residential Present: Residential	
7	ACCESSIBILITY TO PUBLIC: Exterior visible from public road: Yes 🖾 No 🗆

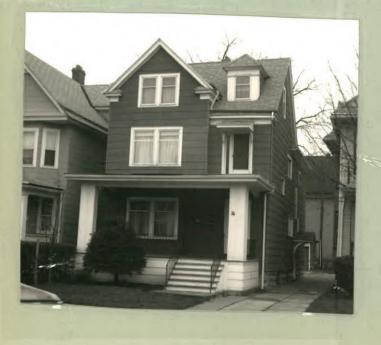
12. PHOTO: 39-1a

e. other	
10	CONDITION: a. excellent \Box b. good \boxtimes c. fair \Box d. deteriorated \Box	
	. INTEGRITY: a. original site \boxtimes b. moved \square if so, when?	
1 25	c. list major alterations and dates (if known):	
	Porch remodeled	
	FOICH LEMODELED

18. OTHER NOTABLE FEATURES OF BUILDING AND SITE (including interior features if known): Two and a half story Princess Anne residence. Side gable roof with cornice end returns. Full-width flat roof porch with eave overhang. Square pier supports at porch corners. Boxed left bay first floor has paired single hung windows with diamond shaped tracery in top light. Light recessed bay has glass and wood paneled door. Second floor has 1-1/2 story gabled boxed bay. Cornice end <u>SIGNIFICANCE</u> 19. DATE OF INITIAL CONSTRUCTION: 1903 returns. Paired single hung,

single light windows on ARCHITECT: second floor and gable. Right bay second floor has three-light wood door flanked on one side by single BUILDER: light sidelight. Shed roof hood. Hip roof dormer has single-hung window, diamond tracery in top light.
