BUILDING-STRUCTURE INVENTORY FORM

- 1. BUILDING NAME(S): _____
- 2. COUNTY: Erie TOWN/CITY: Buffalo VILLAGE: _____
- 3. STREET LOCATION: 1461-1463 Amherst St
- 4. OWNERSHIP: a. public b. private
- 5. PRESENT OWNER: Gary W. Stanton ADDRESS: 1461-1463 Amherst St., Bflo
- 6. USE: Original: Residence Present: Residence
- 7. ACCESSIBILITY TO PUBLIC: Exterior visible from public road: Yes No
Interior accessible: Explain By Permission

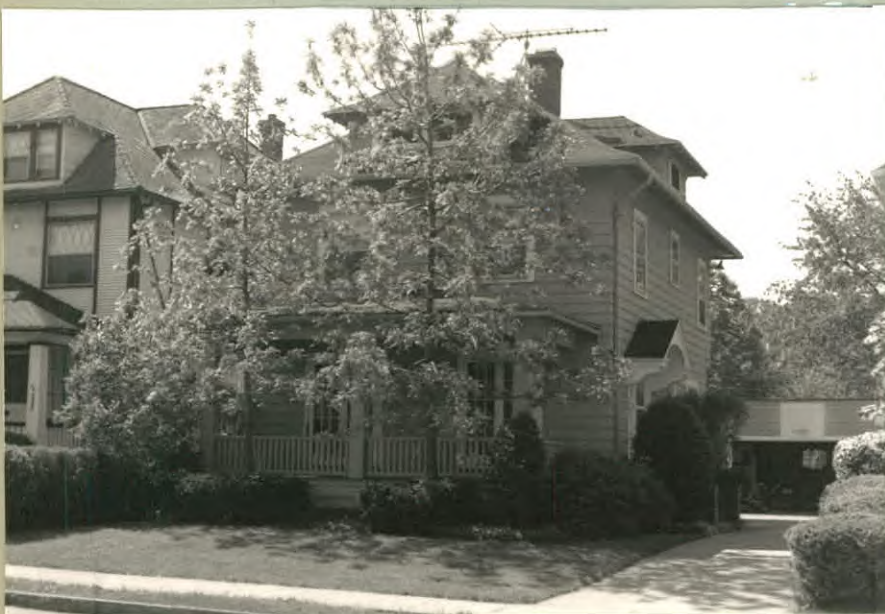
12. PHOTO: 42-9a

18. OTHER NOTABLE FEATURES OF BUILDING AND SITE (including interior features if known):
Two and one half story American Four Square. Hip roof with projecting eaves and exposed rafter tails. West side has pedimented entrance hood supported by end brackets. Wood paneled door with sidelights. One story hip roof porch with square supports, stick balustrade. Multi-light double sash doors lead to porch. Square-headed 8/1 windows. Hip roof dormer with flared eaves. A set of paired 4 light windows in dormer.
