BUILDING-STRUCTURE INVENTORY FORM

- BUILDING NAME(S): _____
- COUNTY: Erie TOWN/CITY: Buffalo VILLAGE: _____
- STREET LOCATION: 2268 Main St
- OWNERSHIP: a. public b. private
- PRESENT OWNER: NYS Dept of Hygiene ADDRESS: 2268 Main Street
- USE: Original: Residential Present: Commercial/Residential
- ACCESSIBILITY TO PUBLIC: Exterior visible from public road: Yes No
Interior accessible: Explain by permission

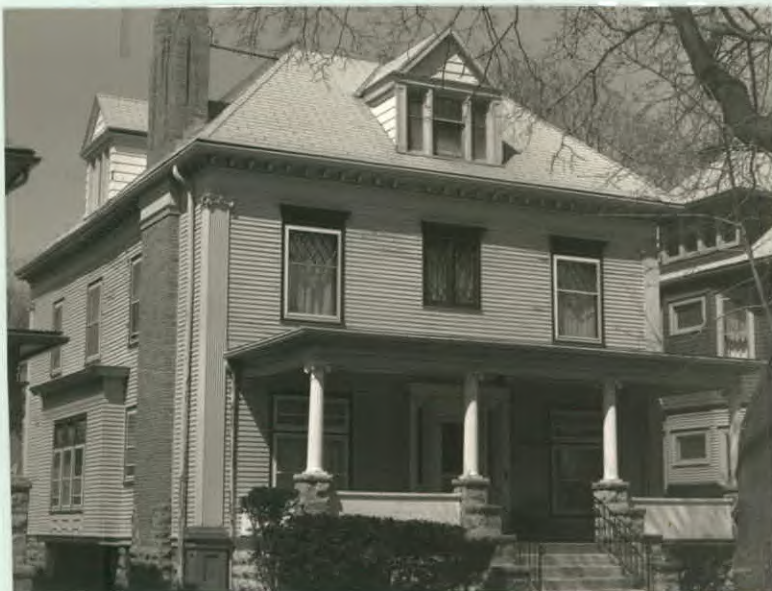
12. PHOTO: 29-10a

Two and a half story Colonial Revival style. Hip roof with small brackets and dentils under eave. Full-width flat roof porch. Rough cut, regular coursed stone base. Fluted Ionic columns support entablature. Paneled rail. Glass paneled door. Leaded sidelights. Wood paneled transom. Fluted Doric engaged columns flank door. Doric pilaster strips flank entrance and support entablature. Dentils

19. DATE OF INITIAL CONSTRUCTION: c. 1898
ARCHITECT: windows, single light with transom. Second floor center has paired leaded casement window. Doric engaged column mullion. Entablature window head. End bays have double sash windows with diamond-shaped tracery in top light. Entablature window head with dentils under cornice. End fluted Ionic pilaster strips. Entablature with dentils. Pedimented gable dormer. Three part 1/1 windows. End paneled pilaster strips support entablature.
20. HISTORICAL AND ARCHITECTURAL IMPORTANCE:
