**BUILDING-STRUCTURE INVENTORY FORM**

1. BUILDING NAME(S): \_\_\_\_\_
2. COUNTY: Erie TOWN/CITY: Buffalo VILLAGE: \_\_\_\_\_
3. STREET LOCATION: 90 Woodward Ave
4. OWNERSHIP: a. public  b. private
5. PRESENT OWNER: Bernard Wagner ADDRESS: 90 Woodward
6. USE: Original: Residential Present: Residential
7. ACCESSIBILITY TO PUBLIC: Exterior visible from public road: Yes  No   
 Interior accessible: Explain by permission

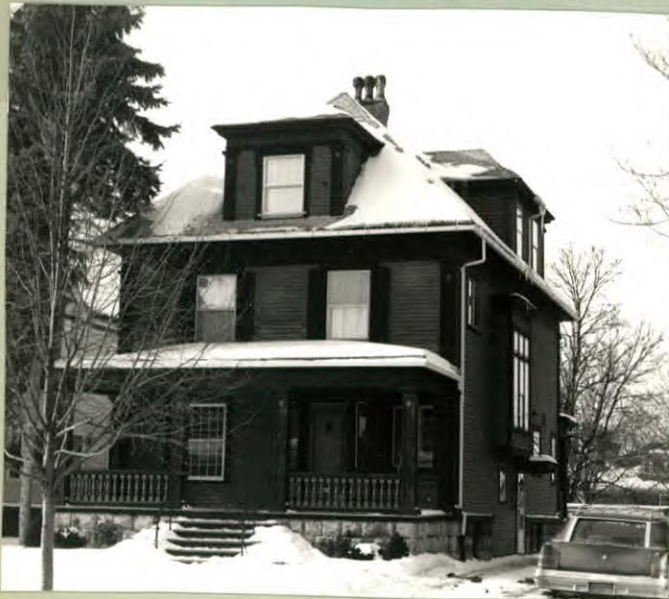
12. PHOTO: 20-26a

Two and a half story Colonial Revival style. Hip roof. Full-width porch has square paneled Doric supports, spindle balustrade, entablature. Wood paneled door with leaded sidelights. Entrance flanked by casement window, 10 lights each. First floor multi-light window. Second floor 12/1 light window with window shutters.

**SIGNIFICANCE** Hip roof dormer has Doric pilaster strips supporting entablature. 8/1 light
