**BUILDING-STRUCTURE INVENTORY FORM**

1. BUILDING NAME(S): \_\_\_\_\_
2. COUNTY: Erie TOWN/CITY: Buffalo VILLAGE: \_\_\_\_\_
3. STREET LOCATION: 95 Woodward Ave
4. OWNERSHIP: a. public  b. private
5. PRESENT OWNER: Alice Dellinger ADDRESS: 95 Woodward
6. USE: Original: Residential Present: Residential
7. ACCESSIBILITY TO PUBLIC: Exterior visible from public road: Yes  No   
 Interior accessible: Explain by permission

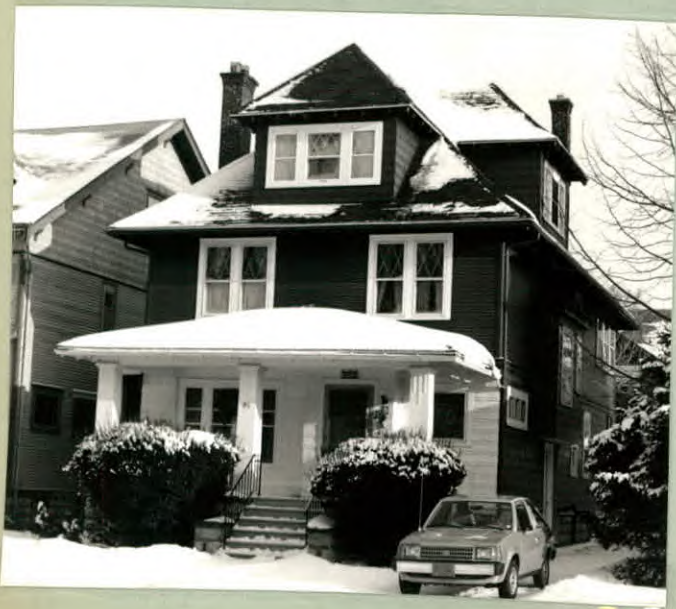
12. PHOTO: 23-19a

Two and a half story American Four Square. Hip roof with rafter tails under eaves. Full-width porch has tapered Doric supports, column elaboration. Projecting entrance has wood paneled door. Square leaded window flanks entrance. Tri-part first floor window, single light with leaded transom. Second floor has a pair of square-headed windows, diamond tracery in top light. Hip roof
