# BUILDING-STRUCTURE INVENTORY FORM

1. BUILDING NAME(S): \_\_\_\_\_  
2. COUNTY: Erie TOWN/CITY: Buffalo VILLAGE: \_\_\_\_\_  
3. STREET LOCATION: 1474 Amherst St  
4. OWNERSHIP: a. public ☐ b. private ☒  
5. PRESENT OWNER: Thomas R. Shelby ADDRESS: 1474 Amherst Street  
6. USE: Original: Residence Present: Residence  
7. ACCESSIBILITY TO PUBLIC: Exterior visible from public road: Yes ☒ No ☐  
Interior accessible: Explain By Permission

12. PHOTO: 42-1a

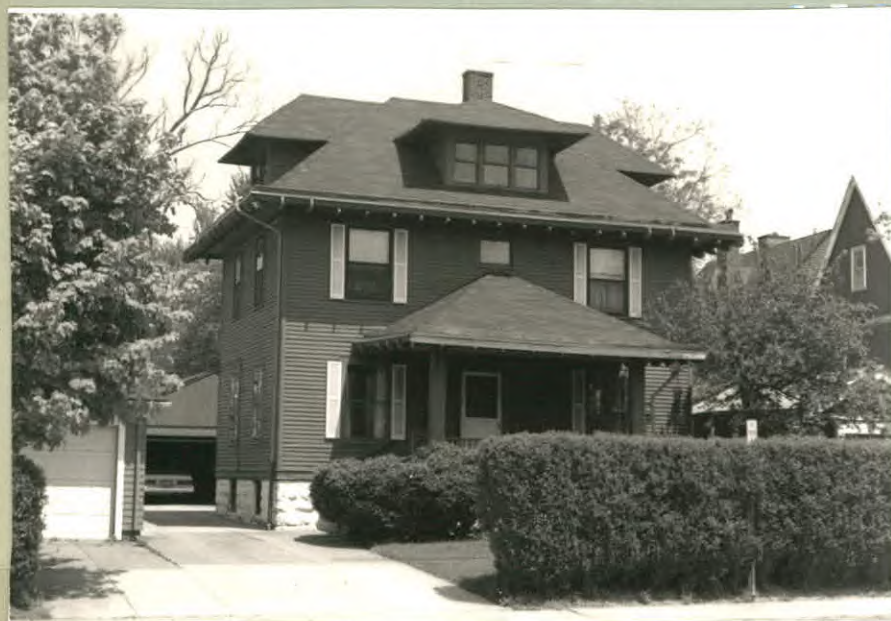
Two and one half story American Four Square. Hip roof with flared eaves and exposed rafter tails. Hip roof porch has exposed rafter tails, square supports, stick balustrade. Square-headed windows 1/1 lights on first and second floor. Small rectangular single light window over porch on second floor. Hip roof dormer with flared eaves. Tri-partite 1/1 window.
