BUILDING-STRUCTURE INVENTORY FORM

ORGANIZATION (if any): City of Buffalo - Division of Planning

- 1. BUILDING NAME(S): _____
- 2. COUNTY: Erie TOWN/CITY: Buffalo VILLAGE: _____
- 3. STREET LOCATION: 1508 Amherst ST
- 4. OWNERSHIP: a. public b. private
- 5. PRESENT OWNER: Helen Benson ADDRESS: 1508 Amherst St., Bflo
- 6. USE: Original: Residence Present: Residence
- 7. ACCESSIBILITY TO PUBLIC: Exterior visible from public road: Yes No
Interior accessible: Explain By Permission

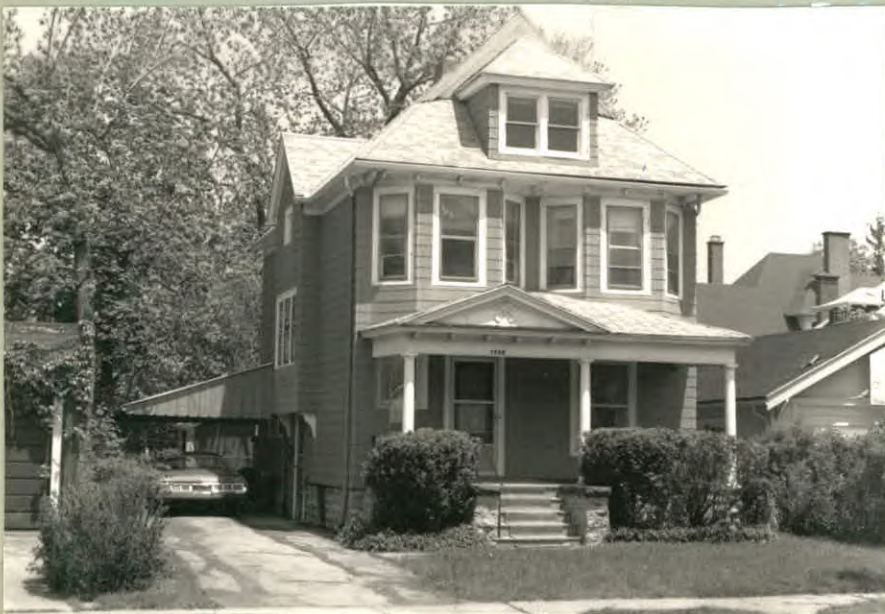
12. PHOTO: 42-2a

Two and one half story simplified Colonial Revival Style. Gable roof with front hip extension. Brackets under eave, paired at building ends. Hip roof dormer with square-headed 1/1 windows, paired. Hip roof full-length porch with pedimented entrance. Doric column supports. Brackets under pediment's cornice. Tympanum decorated with musical emblem. Glass paneled door. Second floor has a set of semi-hexagonal bay windows, square-headed 1/1 windows.
