BUILDING-STRUCTURE INVENTORY FORM

1. BUILDING NAME(S): 2. COUNTY: Erie TOWN/CITY:Buffalo VILLAGE:
2. COUNTY:
3. STREET LOCATION: 99 Russell AVE
4. OWNERSHIP: a. public □ b. private ☒
5. PRESENT OWNER: Stella Sawyer ADDRESS: 99 Russell

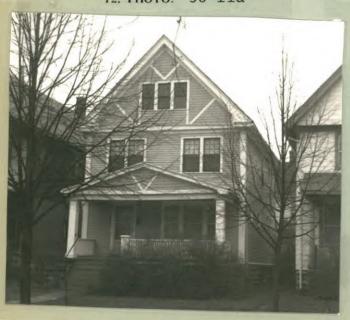
12. РНОТО: 38-11а

18. OTHER NOTABLE FEATURES OF BUILDING AND SITE (including interior features if known): Two and a half story frame with front facing gable roof. Full			
width gabled porch. Rough cut, regular course stone base. Squa	are		
Doric end supports. Stick balustrade. Gable, shingled, with			
stick styling. Bargeboard with flared ends. Three-light wood			
paneled door in left bay first floor. Three-part window, center	r		
SIGNIFICANCE 12/1 light with 9/1 sides. Entablature window and

19. DATE OF INITIAL CONSTRUCTION: c. 1910 door surround. Second floor	OOL		
left and right bay has ARCHITECT: paired double hung 9/1 windows. Entablature window			
surrounds. Pediment shaped panel spans second floor	or.		
BUILDER: Doric end pilaster strips. Gable with cornice end			
returns. Bargeboard. Stick styling. Three-part
