BUILDING-STRUCTURE INVENTORY FORM

- 1. BUILDING NAME(S): _____
- 2. COUNTY: Erie TOWN/CITY: Buffalo VILLAGE: _____
- 3. STREET LOCATION: 133 Summit Ave
- 4. OWNERSHIP: a. public b. private
- 5. PRESENT OWNER: Robert Montgomery ADDRESS: 133 Summit
- 6. USE: Original: Residential Present: Residential
- 7. ACCESSIBILITY TO PUBLIC: Exterior visible from public road: Yes No
Interior accessible: Explain by permission

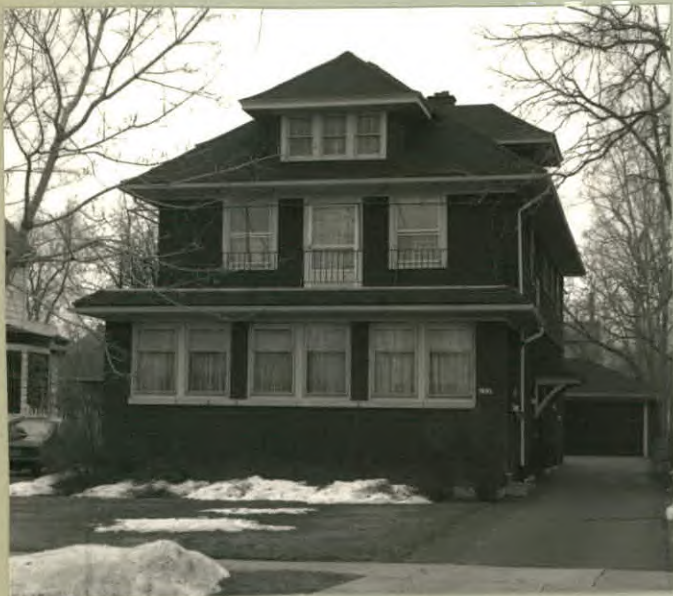
12. PHOTO: 26-6a

Two and a half story American Four Square. Hip roof with extending eave. Full-width flat topped hip roof wing. Paired 4 vertical light over 1 windows. Second floor double sash lighted porch door. Second floor windows; 5 vertical lights over 1, situated under roof eave. Hip roof dormer with extending eave. Three part window, three vertical lights over 1. Brick

SIGNIFICANCE
 19. DATE OF INITIAL CONSTRUCTION: 1924 first floor and second floor shingle. Entrance on south side has hip
 ARCHITECT: _____
 roof curve supported by curved brackets. Glass
 BUILDER: paneled door with 3 light transom. Sidelights.
