**BUILDING-STRUCTURE INVENTORY FORM**

- BUILDING NAME(S): \_\_\_\_\_
- COUNTY: Erie TOWN/CITY: Buffalo VILLAGE: \_\_\_\_\_
- STREET LOCATION: 76 Greenfield St
- OWNERSHIP: a. public  b. private
- PRESENT OWNER: Ruthann Tutaro ADDRESS: 76 Greenfield
- USE: Original: Residential Present: Residential
- ACCESSIBILITY TO PUBLIC: Exterior visible from public road: Yes  No   
Interior accessible: Explain by permission

19. DATE OF INITIAL CONSTRUCTION: 1902

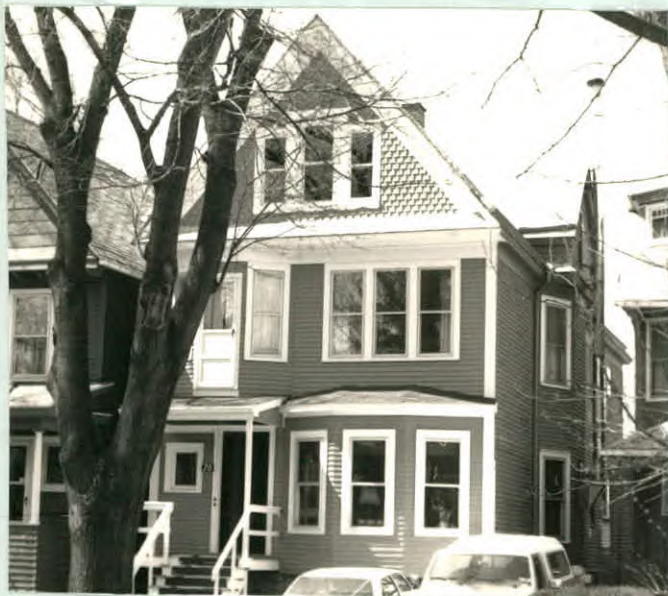
12. PHOTO: 31-17

Two and a half story frame residence with front facing gable roof. Shed roof entrance porch has slender stick supports and balustrade. Glass paneled door flanked on one side by small rectangular single light window. Semi-hexagonal hip roof bay on first floor has double hung 1/1 windows. Plain window surround. Second floor left bay has semi-hexagonal bay. Center glass panel and wood porch door flanked by

ARCHITECT: Tri-part window, double hung 1/1 window. Shingled pedimented gable with flared extending eave. Band of  
 BUILDER: trim below eave. Palladian style gable window.

20. HISTORICAL AND ARCHITECTURAL IMPORTANCE: A frame gabled residence with Colonial Revival details applied to facade. Greenfield Street extends from Amherst Street to Main Street, paralleling the Belt Line Railroad. Although Greenfield Street was deeded to the city in 1889, it was laid out in 1886 by the Parkside Land Company, which had purchased the land between Amherst Street and West Oakwood Place from two major landowners, Elam R. Jewett and Washington Russell. A street very similar in configuration appears in Olmsted's early 1870's maps of "The Parkside." Greenfield follows Olmsted's plan for providing easy access to major streets while being too narrow for extensive commercial development, although some commercial buildings can be found near Main Street.
