**BUILDING-STRUCTURE INVENTORY FORM**

1. BUILDING NAME(S): \_\_\_\_\_
2. COUNTY: Erie TOWN/CITY: Buffalo VILLAGE: \_\_\_\_\_
3. STREET LOCATION: 147 Jewett Pkwy
4. OWNERSHIP: a. public  b. private
5. PRESENT OWNER: Joseph G. Alessi ADDRESS: 147 Jewett Parkway
6. USE: Original: Residential Present: Residential
7. ACCESSIBILITY TO PUBLIC: Exterior visible from public road: Yes  No   
 Interior accessible: Explain by permission.

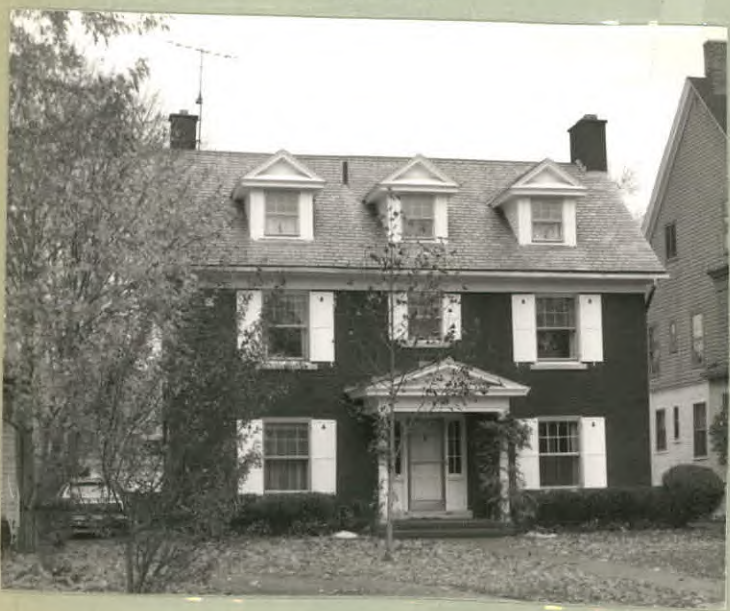
12. PHOTO: 18-30a

Two and a half story Colonial Revival style house. Gable roof with three gabled dormers on front facade. Dormers have one six light over single pane window each. Slate roof. Eight light over single pane windows on first and second floor of house. Six light over single pane window over entranceway. Entranceway has a gabled roof SIGNIFICANCE with doric columns. Doorway with six light sidelights.
