BUILDING-STRUCTURE INVENTORY FORM

- 1. BUILDING NAME(S): \_\_\_\_\_
- 2. COUNTY: Erie TOWN/CITY: Buffalo VILLAGE: \_\_\_\_\_
- 3. STREET LOCATION: 98 Crescent Ave
- 4. OWNERSHIP: a. public  b. private
- 5. PRESENT OWNER: Paul Dowling ADDRESS: 98 Crescent
- 6. USE: Original: Residential Present: Residential
- 7. ACCESSIBILITY TO PUBLIC: Exterior visible from public road: Yes  No   
Interior accessible: Explain by permission

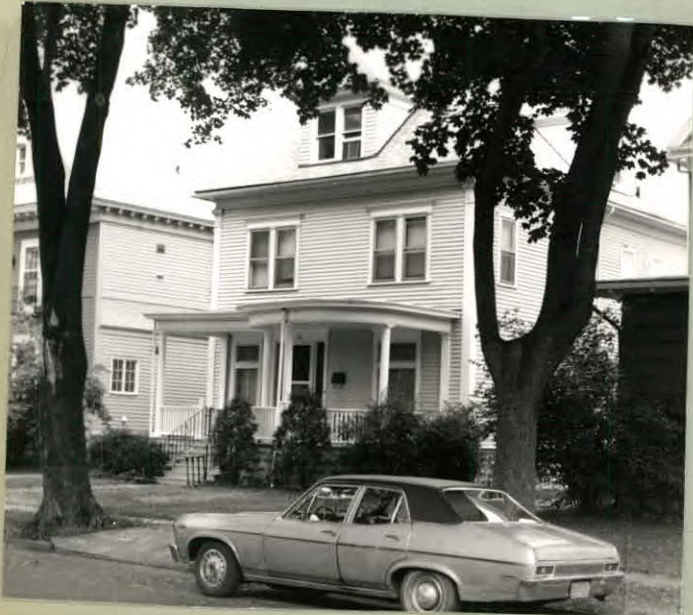
12. PHOTO: 9-12a

18. OTHER NOTABLE FEATURES OF BUILDING AND SITE (including interior features if known):  
 Classical Revival with hip roof and fluted pilaster corner boards. Pedimented facade dormer has scroll work tympanum. Large porch has circular extension and is supported on slender fluted columns. Doorway sidelights have leaded glass.
