BUILDING-STRUCTURE INVENTORY FORM

1. BUILDING NAME(S): _____
2. COUNTY: Erie TOWN/CITY: Buffalo VILLAGE: _____
3. STREET LOCATION: 108 Woodward Ave
4. OWNERSHIP: a. public b. private
5. PRESENT OWNER: Yerby Dixon ADDRESS: 108 Woodward
6. USE: Original: Residential Present: Residential
7. ACCESSIBILITY TO PUBLIC: Exterior visible from public road: Yes No
 Interior accessible: Explain by permission

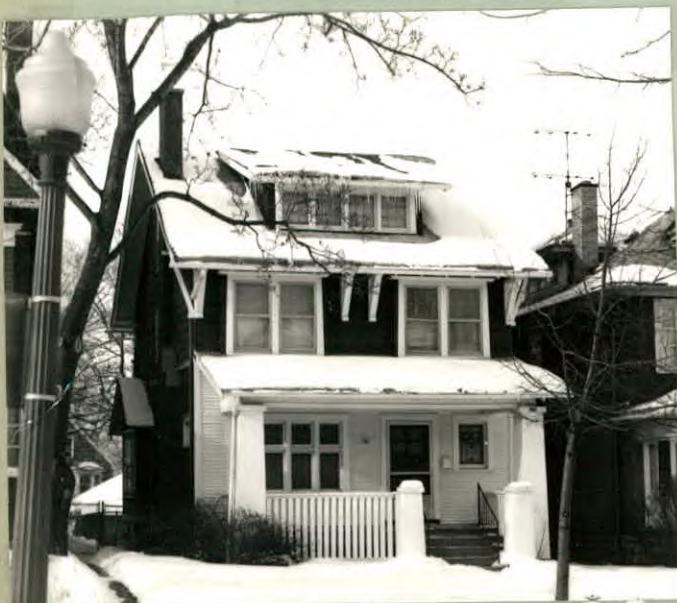
12. PHOTO: 20-30a

Two and a half story with Craftsman style details. Side gable roof with exposed rafter tails and triangular knee braces under extending eave. Shed roof full-width porch has tapered square supports. Stick rail. Rafter tails under eave. 4-light wood paneled door flanked by small rectangular leaded window. Tripart window on first floor, single lights with leaded transoms.

19. DATE OF INITIAL CONSTRUCTION: 1911 Second floor has a set of boxed bays, paired
 ARCHITECT: _____ 6/1 light windows. Shed
 BUILDER: _____ roof dormer has four-square 9-light window
