BUILDING-STRUCTURE INVENTORY FORM

UNIQUE SITE NO. 029-40-4799 D07
QUAD _____
SERIES _____
NEG. NO. _____

- 1. BUILDING NAME(S): _____
- 2. COUNTY: Erie TOWN/CITY: Buffalo VILLAGE: _____
- 3. STREET LOCATION: 1550 Amherst St
- 4. OWNERSHIP: a. public b. private
- 5. PRESENT OWNER: Ralph W. Gordon ADDRESS: 1550 Amherst Street, Bflo
- 6. USE: Original: Residence Present: Residence
- 7. ACCESSIBILITY TO PUBLIC: Exterior visible from public road: Yes No
Interior accessible: Explain By Permission

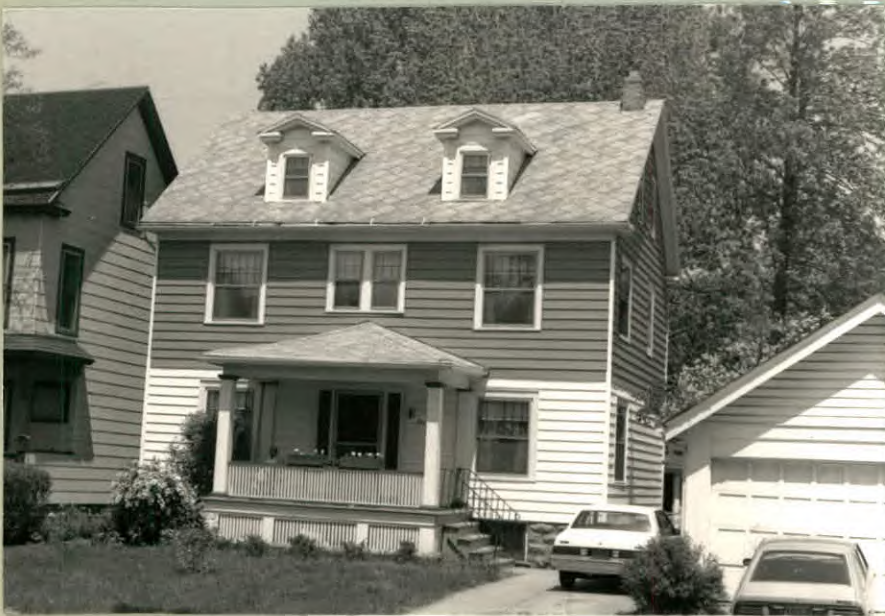
12. PHOTO: 42-4a

Two and one half story with Colonial Revival detailing. Side gable roof with cornice end returns. Pedimented dormers with cornice end returns. Square-headed 3/1 windows. Hip roof entrance porch has square supports, stick balustrade. Paneled wood door with sidelights. Second story center paired square-headed 6/1 window flanked by 12/1 windows.
