**BUILDING-STRUCTURE INVENTORY FORM**

1. BUILDING NAME(S): \_\_\_\_\_
2. COUNTY: Erie TOWN/CITY: Buffalo VILLAGE: \_\_\_\_\_
3. STREET LOCATION: 2322-2324 Main St
4. OWNERSHIP: a. public  b. private
5. PRESENT OWNER: Alfred Villa ADDRESS: 2322-24 Main Street
6. USE: Original: Commercial/Residential Present: Commercial/Residential
7. ACCESSIBILITY TO PUBLIC: Exterior visible from public road: Yes  No   
 Interior accessible: Explain by permission

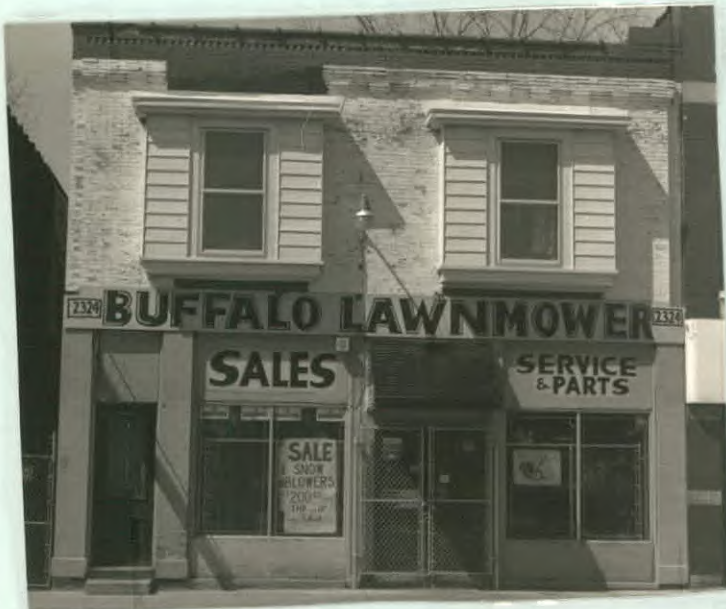
12. PHOTO: 29-22a

Two story brick commercial/residential row building. Flat roof with front parapet. First floor center bay has double glass paneled doors flanked by two single light commercial windows. Left end bay has glass and wood paneled door. Brick piers flank door and building end. Second floor has recessed ends. Two boxed flat roof oriels. Double hung 1/1 window. Caping cornice. Corbel

19. DATE OF INITIAL CONSTRUCTION: 1906  
 ARCHITECT: \_\_\_\_\_  
 BUILDER: \_\_\_\_\_
- panel spans entire building.  
 Zig-zag molding below  
 parapet top. Parapet cap  
 decorated with boss motif.
