BUILDING-STRUCTURE INVENTORY FORM DIVISION FOR HISTORIC PRESERVATION NEW YORK STATE PARKS AND RECREATION ALBANY, NEW YORK (518) 474-0479	FOR OFFICE USE ONLY UNIQUE SITE NO40.8 DO QUAD SERIES NEG. NO
YOUR NAME: BUFFALO FRIENDS OF OLMSTED PARK	5 DATE: <u>February 3, 198</u> 4

1. BUILDING NAME (S):	
2. COUNTY: Erie TOWN/CITY E	
3. STREET LOCATION: 107 Crescent AVE	<u>}</u>
4. OWNERSHIP: a. public 🗆 b. private 🖾	
5. PRESENT OWNER: Charles Arnold III A

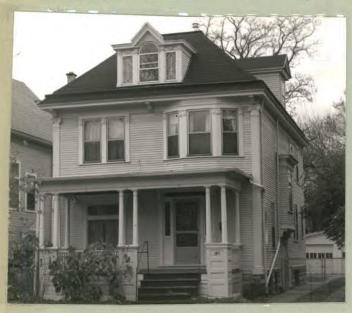
12. PHOTO: 11-14a

Hip roof Colonial Revival. The truncated hip roof has a palladian window dormer in front with gable over center arched window. Facade cornice overhang is supported by three carved acanthus leaf modillions. Corner boards are fluted ionic pilasters. Porch is supported by slender doric columns with the Adamesque <u>SIGNIFICANCE</u> delicacy of design. Doorway has leaded glass transom 19. DATE OF INITIAL CONSTRUCTION: 1901 and sidelights within an

eared classical architecture.

20. HISTORICAL AND ARCHITECTURAL IMPORTANCE: A finely detailed example of the hip roof Colonial Revival in the Parkside area. Crescent Avenue is the longest curvilinear street in the Parkside subdivision, stretching from Humboldt Avenue to Colvin Street. This street appears on Olmsted's early 1870's maps of "The Parkside." By the 1880's plans for Crescent Avenue had been modified by Olmsted to its current form. Portions of the street were deeded to the city by five different owners over a span of five years, beginning in 1887 near Humboldt and ending in 1892 near Colvin. Crescent Avenue begins and ends within the Parkside subdivision, following Olmsted's rule that a suburban neighborhood street "not lead with special directness toward the town."
