BUILDING-STRUCTURE INVENTORY FORM

1. BUILDING NAME(S): _____
2. COUNTY: Erie TOWN/CITY: Buffalo VILLAGE: _____
3. STREET LOCATION: 130 Tillinghast Pl
4. OWNERSHIP: a. public b. private
5. PRESENT OWNER: Philip Celniker ADDRESS: 130 Tillinghast Place, Bflo
6. USE: Original: Residence Present: Residence
7. ACCESSIBILITY TO PUBLIC: Exterior visible from public road: Yes No
 Interior accessible: Explain By Permission

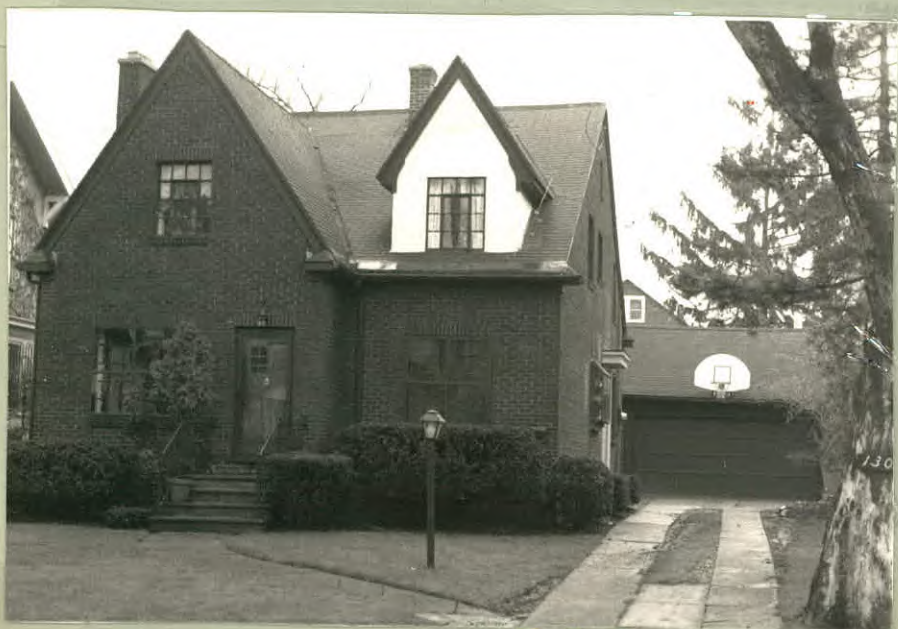
12. PHOTO: 41-9a

Two story Tudor style. Side gable roof with projecting gabled bay. Entrance with relieving arch. First floor windows, double sash, 6 lights with 3 light sidelight and 4 light transom. Relieving arch. Square-headed 6 light window with lighted border. Steep pitched gable dormer, stucco, with bargeboard. West side entrance has entablature door head.
