**BUILDING-STRUCTURE INVENTORY FORM**

- 1. BUILDING NAME(S): \_\_\_\_\_
- 2. COUNTY: Erie TOWN/CITY: Buffalo VILLAGE: \_\_\_\_\_
- 3. STREET LOCATION: 128 Woodward Ave
- 4. OWNERSHIP: a. public  b. private
- 5. PRESENT OWNER: Albert Prentice ADDRESS: 128 Woodward
- 6. USE: Original: Residential Present: Residential
- 7. ACCESSIBILITY TO PUBLIC: Exterior visible from public road: Yes  No   
Interior accessible: Explain by permission

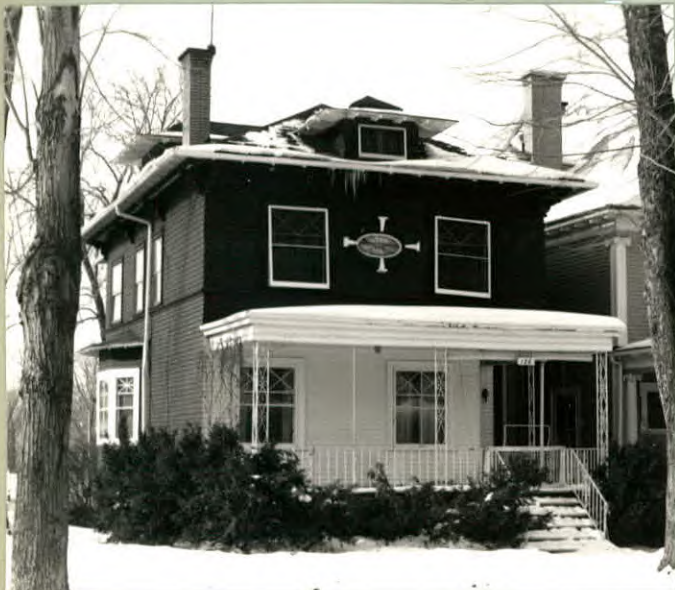
12. PHOTO: 20-33a

Two and a half story American Four Square. Hip roof with rafter tails under extending eaves. Full-width porch. Recessed entrance. 4 light wood door. First and second floor single light windows with diamond tracery in transom. Second floor has elliptical window stained glass with keystones. Hip roof dormer with rafter tails under falred eave. Asterisk tracery in casement dormer window.
