BUILDING-STRUCTURE INVENTORY FORM

- 1. BUILDING NAME(S): _____
- 2. COUNTY: Erie TOWN/CITY: Buffalo VILLAGE: _____
- 3. STREET LOCATION: 114 Crescent Ave
- 4. OWNERSHIP: a. public b. private 11617 Bullis Rd.
- 5. PRESENT OWNER: Ouidio Baiocco ADDRESS: Marilla, NY 14102
- 6. USE: Original: Residential Present: Residential
- 7. ACCESSIBILITY TO PUBLIC: Exterior visible from public road: Yes No
Interior accessible: Explain by permission

19. DATE OF INITIAL CONSTRUCTION: 1902

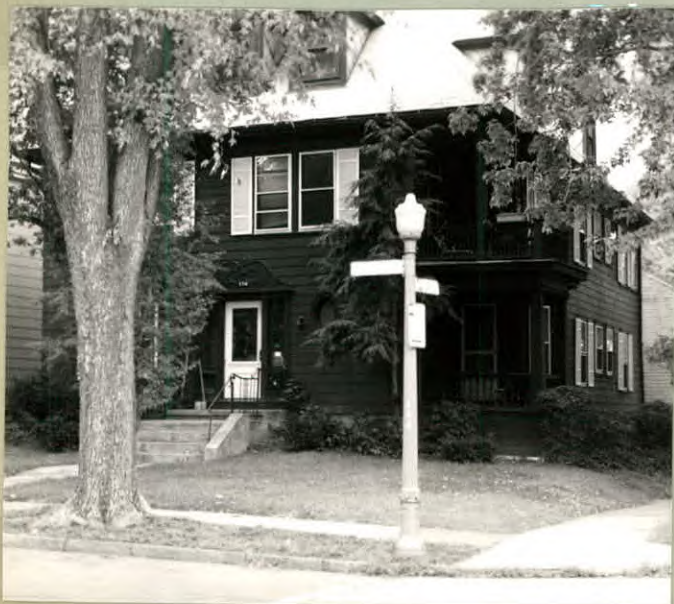
12. PHOTO: 9-8a

- 8. BUILDING MATERIAL: a. clapboard b. stone c. brick d. board and batten
e. cobblestone f. shingles g. stucco other: _____
- 9. STRUCTURAL SYSTEM: a. wood frame with interlocking joints
(if known) b. wood frame with light members
c. masonry load bearing walls
d. metal (explain) _____
e. other _____
- 10. CONDITION: a. excellent b. good c. fair d. deteriorated
- 11. INTEGRITY: a. original site b. moved if so, when? _____
c. list major alterations and dates (if known):
Porch removed
Present wood shingles not original

18. OTHER NOTABLE FEATURES OF BUILDING AND SITE (including interior features if known):
 Colonial Revival house. The large truncated hip roof has paired pedimented dormers on each elevation. Classical scroll broken-pediment over doorway. Oval leaded-glass window near doorway. Small porch on corner has been rebuilt but one ionic capital column remains from earlier design.
