**BUILDING-STRUCTURE INVENTORY FORM**

1. BUILDING NAME(S): \_\_\_\_\_
2. COUNTY: Erie TOWN/CITY: Buffalo VILLAGE: \_\_\_\_\_
3. STREET LOCATION: 2400 Main St
4. OWNERSHIP: a. public  b. private  5 Willow Lawn
5. PRESENT OWNER: George Roberts ADDRESS: Buffalo, NY 14214
6. USE: Original: Residential Present: Commercial/Residential
7. ACCESSIBILITY TO PUBLIC: Exterior visible from public road: Yes  No   
 Interior accessible: Explain by permission

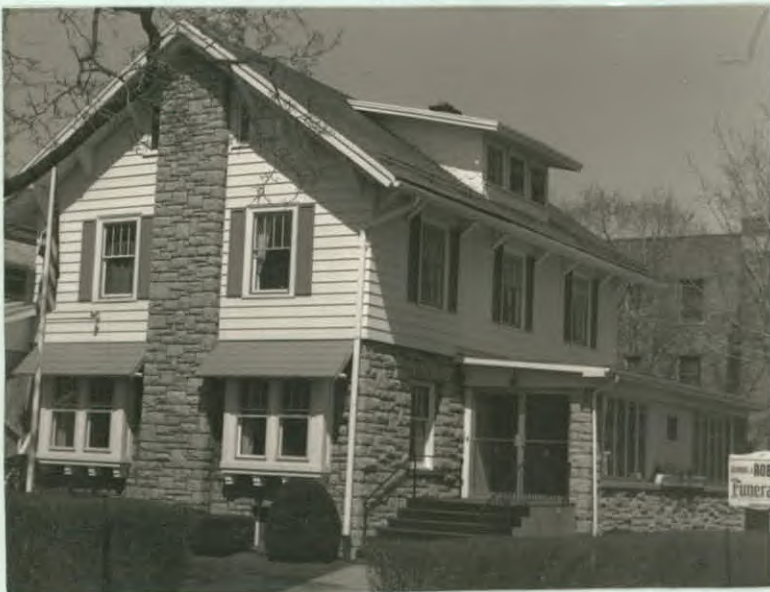
12. PHOTO: 29-26a

Two and a half story Craftsman style. Side gable roof with wedge-shaped brackets under extending eaves. Partial-width shed roof porch. Extending eave. Rough cut irregular course stone. Double glass paneled doors. Four-part casement windows with diamond shaped tracery flanking wood panel. First floor rough cut irregular coursed stone. Double-hung windows. Three vertical lights top light. Stone relieving arch with keystone.

**SIGNIFICANCE** Aluminum siding on second floor. Three bays each have double hung windows. 4 vertical light top light. Louvred window shutters. East facade has center exterior chimney of rough cut irregular coursed stone. First floor has pair shed roof boxed oriels in end bays supported by brackets. Exposed
