**BUILDING-STRUCTURE INVENTORY FORM**

YOUR NAME: BUFFALO FRIENDS OF OLMSTED PARKS DATE: JAN 10 1983  
 P. O. BOX 590  
 YOUR ADDRESS: BUFFALO, NEW YORK 14205-0590 TELEPHONE: \_\_\_\_\_  
 ORGANIZATION (if any): \_\_\_\_\_

1. BUILDING NAME(S): \_\_\_\_\_
2. COUNTY: Erie TOWN/CITY: Buffalo VILLAGE: \_\_\_\_\_
3. STREET LOCATION: 275 Parkside Ave
4. OWNERSHIP: a. public  b. private
5. PRESENT OWNER: Thomas Geelan ADDRESS: 275 Parkside Avenue
6. USE: Original: Residential Present: Residential
7. ACCESSIBILITY TO PUBLIC: Exterior visible from public road: Yes  No   
 Interior accessible: Explain by permission

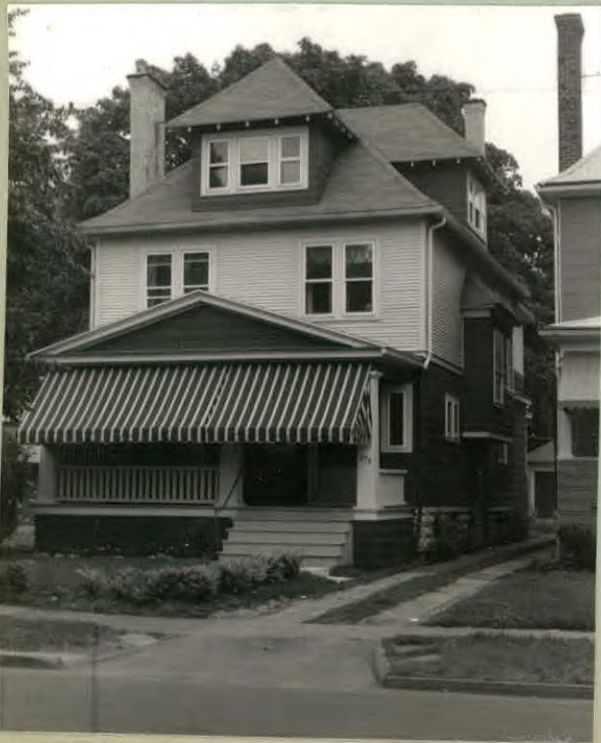
12. PHOTO: 13-31

Two story American Four Square. Hip roof with flared eaves and exposed rafters. Two hipped dormers with exposed rafters and three diamond paned over single pane windows. Projecting bay with a hipped roof on the south side of the house. Two pairs of diamond paned over single pane windows on the second story front facade. Open porch across front of house has a gable roof tapered boxed porch posts and a stick

18. balustrade. Leaded glass windows on either side of the doorway.
