**BUILDING-STRUCTURE INVENTORY FORM**

- 1. BUILDING NAME(S): \_\_\_\_\_
- 2. COUNTY: Erie TOWN/CITY: Buffalo VILLAGE: \_\_\_\_\_
- 3. STREET LOCATION: 126 Russell Ave
- 4. OWNERSHIP: a. public  b. private
- 5. PRESENT OWNER: Judith Harvey ADDRESS: 126 Russell
- 6. USE: Original: Residential Present: Residential
- 7. ACCESSIBILITY TO PUBLIC: Exterior visible from public road: Yes  No   
Interior accessible: Explain by permission

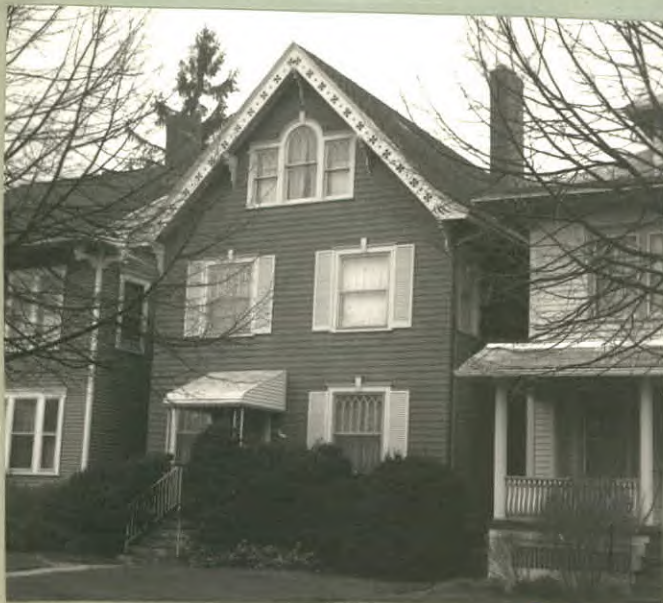
12. PHOTO: 38-26a

18. OTHER NOTABLE FEATURES OF BUILDING AND SITE (including interior features if known):  
 Two and a half story with Colonial Revival styling. Front facing gable roof. Bargeboard with quattrifoil cut-out pattern. Curved bracket supports. Off-center entrance has glass paneled door with Gothic arched tracery, flanked by double-hung windows. Gothic arched tracery in top light. Entablature window surround with keystone. Louvred window shutters on right bay window.

20. HISTORICAL AND ARCHITECTURAL IMPORTANCE: A gabled Colonial Revival style residence with Classical details and Swiss Chalet styling in gable. Russell Avenue extends from Parkside Avenue to Greenfield Street. It was laid out in a map of 1886, paralleling the northern border of the lands of Washington Russell, after whom the street was named. However it was early 1889 before Russell Avenue was deeded to the city. While this particular street does not appear in Olmsted's early 1870's maps of "The Parkside," Olmsted felt cross streets would allow easy access to major thoroughfares and to the park, and he did include similar cross streets such as Jewett Avenue in his early plans.
