BUILDING-STRUCTURE INVENTORY FORM

*	
ID	DENTIFICATION
_	BUILDING NAME (S):
1.	COUNTY: Erie TOWN/CITY: Buffalo VILLAGE:
2.	COUNTY: BITE TOWN/CITY: BULLAGE:
3.	STREET LOCATION: 143 Woodward Ave

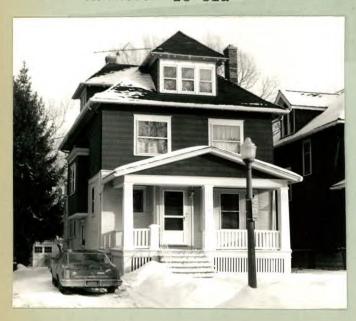
12. PHOTO: 23-31a

17.	(Indicate if building or structure is in an historic district)
B11	ilding is situated on a standard sized lot within Olmsted's
Pai	ckside subdivision. House is located one block from
	laware Park, which was designed by Olmsted and is listed on the
	cional Register, and southeast of the Zoo.
18	OTHER NOTABLE FEATURES OF BUILDING AND SITE (including interior features if known):
Тълс	and a half story American Four Square. Hip roof with rafter
ta	ils under eave. Full-width gable roof porch. Square Doric
sur	oports with column elaboration. Stick balustrade. Projecting
ent	crance has glass and wood paneled door flanked by small
red	ctangular leaded window. Boxed bay on first floor has single
OR CI	light with leaded transom window. Second floor has
19	DATE OF INITIAL CONSTRUCTION: 1912 prism-shaped tracery in top light. Entablature window

• • •	light. Entablature window
	ARCHITECT: surround. Horizontal band course at second floor.
	Hip roof dormer, exposed rafter tails. Three
	BUILDER: windows with prism-shaped tracery in top light.
20	HISTORICAL AND ARCHITECTURAL IMPORTANCE: Typical American Four
