BUILDING-STRUCTURE INVENTORY FORM

1. BUILDING NAME(S): _____
2. COUNTY: Erie TOWN/CITY: Buffalo VILLAGE: _____
3. STREET LOCATION: 160 Woodward Ave
4. OWNERSHIP: a. public b. private
5. PRESENT OWNER: Richard Heller ADDRESS: 160 Woodward
6. USE: Original: Residential Present: Residential
7. ACCESSIBILITY TO PUBLIC: Exterior visible from public road: Yes No
 Interior accessible: Explain by permission

19. DATE OF INITIAL CONSTRUCTION: 1907 floor bay windows, with roof, dentils under cornice. Second floor has center paired elliptical windows with pilaster strips supporting entablature with swag motif in frieze. Pair of bowed bay windows. Entablature with dentils. Pedimented gable, shingled, has Palladian window. Dentils in raking cornice.

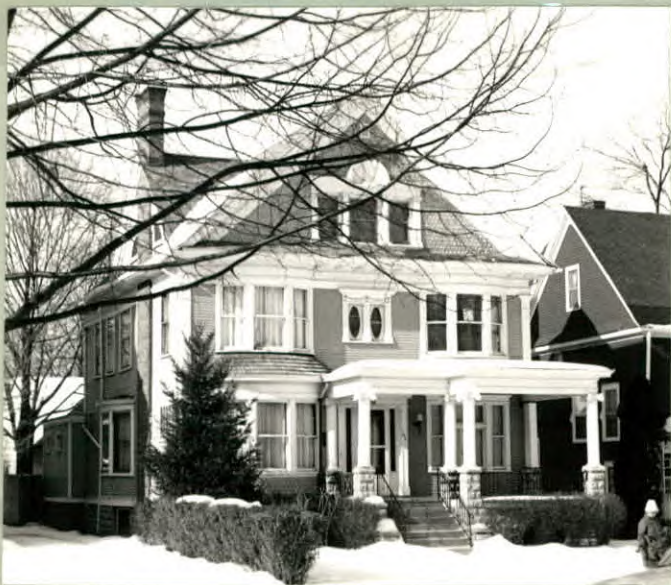
12. PHOTO: 21-7a

Two and a half story Colonial Revival style. Front-facing gable roof. Partial-width porch has Ionic fluted columns on rough cut, regular stone base. Entablature with dentils under cornice. Glass paneled door with sidelights. Pilaster strips support entablature door head with dentils under cornice. Tri-part first floor window, single light with transom center window with 1/1 sidelights. Bowed first
