BUILDING-STRUCTURE INVENTORY FORM	FOR OFFICE USE ONLY
BUILDING-STRUCTURE INVENTORT FORM	000 10 5201
DIVISION FOR HISTORIC PRESERVATION	UNIQUE SITE SO. 40 5794 D
NEW YORK STATE PARKS AND RECREATION	QUAD
	SERIES
ALBANY, NEW YORK (518) 474-0479	NEG. NO
YOUR NAME: P. O. BOX 590	DATE: <u>March 30, 1984</u>
YOUR ADDRESS	TELEPHONE:
ORGANIZATION (if any):

3. STREET LOCATION: 171 Woodward Au	0
4. OWNERSHIP: a. public D b. private	e
5. PRESENT OWNER:James Scandale/	ADDRESS: 171 Woodward
6. USE: Original: Residential F	Present: Residential

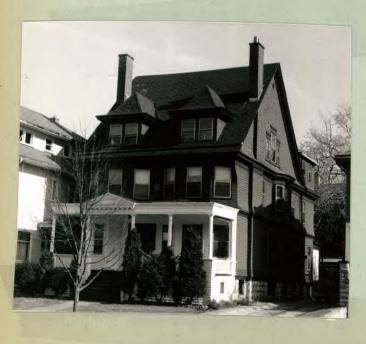
12. PHOTO: 24-2a

e. other 0. CONDITION: a. excellent b. good c	. fair 🗌 d. deteriorated 🗌
e. other 10. CONDITION: a. excellent \Box b. good 🖾 c 11. INTEGRITY: a. original site 🖾 b. moved \Box	. fair d. deteriorated d. dete

18. OTHER NOTABLE FEATURES OF BUILDING AND SITE (including interior features if known): Two and a half story with Colonial Revival styling. Steep pitch side gable roof. Full-width porch has fluted Doric columns, spindle balustrade, entablature with dentils under cornice. Pediment over stairs. Leaf and vine motif in tympanum. Pediment cornice with modillions. Double glass and wood paneled door. First and second floor has semi-hexagonal bays. 19. DATE OF INITIAL CONSTRUCTION: c. 1905 1/1 light windows. Dentils under roof eave. Hip roof

ARCHITECT:		dormer with flared eaves.
	Paired 1/1 windows	. Gable ends have Palladian
BUILDER:	window adaptation.
