## **BUILDING-STRUCTURE INVENTORY FORM**

DIVISION FOR HISTORIC PRESERVATION NEW YORK STATE PARKS AND RECREATION ALBANY, NEW YORK (518) 474-0479

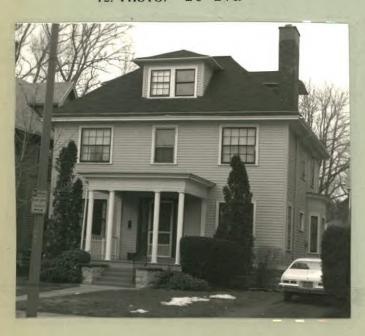
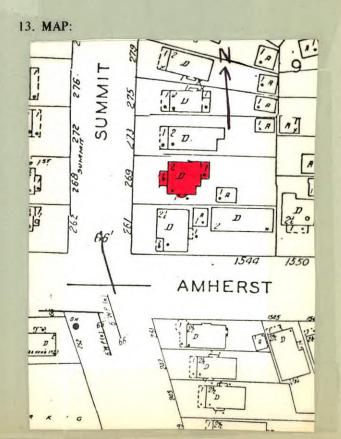
12. РНОТО: 26-27а

18.	OTHER NOT	ABLE FEATURES OF BUILDING AND SITE (including interior features if known):
Two	and a h	alf story American Four Square form with Colonial
Rev	vival sty	ling. Hip roof. Symmetrical facade. Flat-roof
ent	rance po	rch has fluted Doric columns supporting entablature.
Sty	rlized na	turalistic forms decorate frieze. Dentils under
		tick balustrade. Glass and wood paneled door with
SIGN	NIFICANCE	single light sidelights. First and second floor

19.	DATE OF IN	ITIAL CONSTRUCTION: c. 1894 8/8 light windows.  Center second floor 1/1
	ARCHITECT	window. Hip roof dormer
	ARCHITECT	with pair of double hung
	BUILDER:_	windows, 6/6 light and 1/1 light.
		AND ARCHITECTURAL IMPORTANCE: A typical American Four
		dence with Colonial Revival styling applied to facade. ue is a truncated north-south street, located between
		d Crescent Avenues and extending from West Oakwood
		e northern section of Crescent Avenue. A similar
		ing south of Jewett Avenue, appears in Olmsted's
ear	ly 1870's	s maps of "The Parkside." Summit Avenue was deeded
to	the city	in 1889, except for the small section between
		Crescent which was deeded in 1892. This street
	ard the	sted's rule that it "not lead with special directness
LOW	ard the	LOWII.
