**BUILDING-STRUCTURE INVENTORY FORM**

- 1. BUILDING NAME(S): \_\_\_\_\_
- 2. COUNTY: Erie TOWN/CITY: Buffalo VILLAGE: \_\_\_\_\_
- 3. STREET LOCATION: 293 Summit Ave
- 4. OWNERSHIP: a. public  b. private
- 5. PRESENT OWNER: Thomas Rizzo ADDRESS: 293 Summit
- 6. USE: Original: Residential Present: Residential
- 7. ACCESSIBILITY TO PUBLIC: Exterior visible from public road: Yes  No   
Interior accessible: Explain by permission

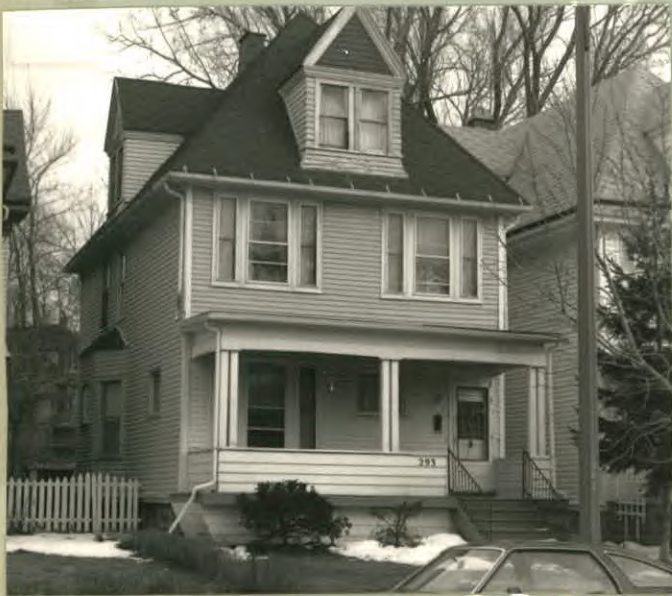
12. PHOTO: 26-33a

Two and a half story frame residence with steep pitched hip roof. Full-width flat roof porch has paired slender, square supports. Clapboard rail. Glass and wood paneled door flanked on one side by rectangular single light window. First floor three part window, 1/1 lights. Second floor has pair of three part 1/1 windows. Steep pitched pedimented gabled

SIGNIFICANCE DATE OF INITIAL CONSTRUCTION: c. 1909 dormers. Paired 1/1 windows.

20. HISTORICAL AND ARCHITECTURAL IMPORTANCE: An American Four Square with Colonial Revival styling. Summit Avenue is a truncated north-south street, located between Woodward and Crescent Avenues and extending from West Oakwood Place to the northern section of Crescent Avenue. A similar street, ending south of Jewett Avenue, appears in Olmsted's early 1870's maps of "The Parkside." Summit Avenue was deeded to the city in 1889, except for the small section between Amherst and Crescent which was deeded in 1892. This street follows Olmsted's rule that it "not lead with special directness toward the town."
