**BUILDING-STRUCTURE INVENTORY FORM**

1. BUILDING NAME(S): \_\_\_\_\_
2. COUNTY: Erie TOWN/CITY: Buffalo VILLAGE: \_\_\_\_\_
3. STREET LOCATION: 239 Crescent Ave
4. OWNERSHIP: a. public  b. private
5. PRESENT OWNER: Henry Johnson ADDRESS: 239 Crescent
6. USE: Original: Residential Present: Residential
7. ACCESSIBILITY TO PUBLIC: Exterior visible from public road: Yes  No   
 Interior accessible: Explain by permission

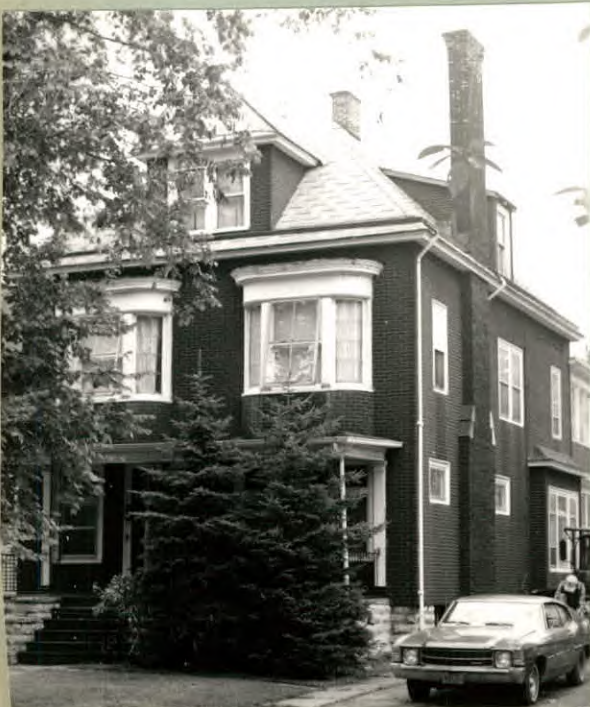
12. PHOTO: 10-3a

8. BUILDING MATERIAL: a. clapboard  b. stone  c. brick  d. board and batten   
 e. cobblestone  f. shingles  g. stucco  other: asphalt
9. STRUCTURAL SYSTEM: a. wood frame with interlocking joints   
 (if known) b. wood frame with light members   
 c. masonry load bearing walls   
 d. metal (explain) \_\_\_\_\_  
 e. other \_\_\_\_\_
10. CONDITION: a. excellent  b. good  c. fair  d. deteriorated
11. INTEGRITY: a. original site  b. moved  if so, when? \_\_\_\_\_  
 c. list major alterations and dates (if known):  
Porch supports and balustrade altered

18. OTHER NOTABLE FEATURES OF BUILDING AND SITE (including interior features if known):  
Two and a half story with Colonial Revival styling. Hip roof. Full-width flat roof porch. Dentils under cornice. Glass paneled door. First floor tri-part window, center single light with leaded transom, 1/1 sidelights. Second floor has a pair of bowed bays, center window 1/1 light with leaded sidelights. SIGNIFICANCE Gabled dormer has a pair of 1/1 windows.
