**BUILDING-STRUCTURE INVENTORY FORM**

1. BUILDING NAME(S): \_\_\_\_\_
2. COUNTY: Erie TOWN/CITY: Buffalo VILLAGE: \_\_\_\_\_
3. STREET LOCATION: 254 Crescent Ave
4. OWNERSHIP: a. public  b. private
5. PRESENT OWNER: Richard Woelfel ADDRESS: 254 Crescent
6. USE: Original: Residential Present: Residential
7. ACCESSIBILITY TO PUBLIC: Exterior visible from public road: Yes  No   
 Interior accessible: Explain by permission

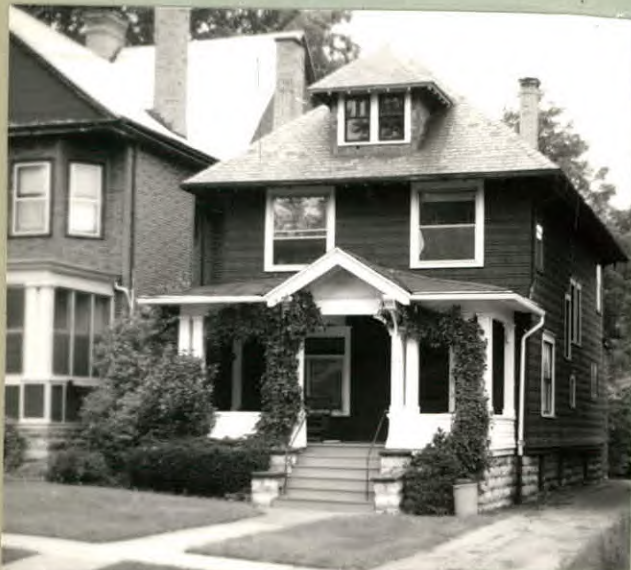
12. PHOTO: 8-3a

Two and a half story with Craftsman styling. Hip roof with exposed rafter tails under extending eaves. Full-width hip roof porch with gabled projection supported by end brackets, paired tapered square supports, shingled rail. Glass paneled door. First floor single light window with leaded transom. Entablature window surround. Second floor 1/1 windows. Hip roof

- SIGNIFICANCE** dormer with exposed rafter tails under eave. Prism shaped lights in top light of paired dormer windows.
19. DATE OF INITIAL CONSTRUCTION: 1908
- ARCHITECT: \_\_\_\_\_
- BUILDER: \_\_\_\_\_
